# Access Compliance Report Public Rights-of-Way (Curb Ramps)

Main Street: **BERKELEY\_ST** Cross Street: **LINCOLN\_AVE** Location: **SW**

ADA ID: **RPAT210924083551** Ramp Type: **Type 4 - Parallel** Initial Pass/Fail: **Pass** Overall Compliance: **No** Severity Score: **0**

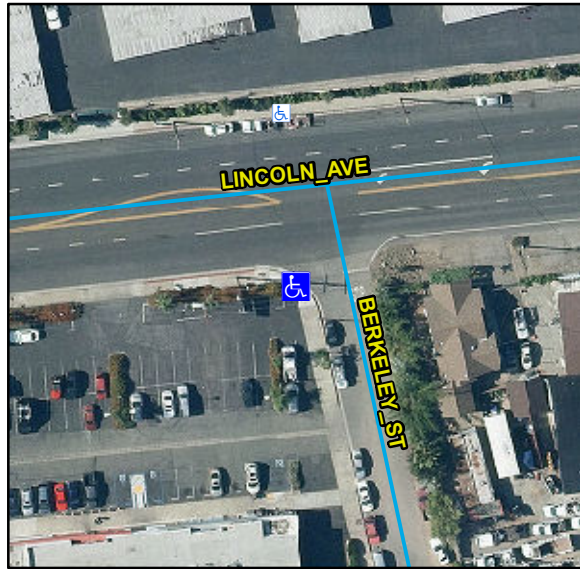
| Compliance | Description | Data | Compliance | Description | Data |
|---|---|---|---|---|---|
| <b>No</b> | Landing Cross Slope (%) | <b>2.1</b> | | DWS Offset Type | <b>Single</b> |
| <b>No</b> | Gutter Cross Slope (%) | <b>2.3</b> | <b>Yes</b> | Perpendicular Joint Present | <b>Yes</b> |

**Remove & Replace Landing. Remove & Replace Gutter.**

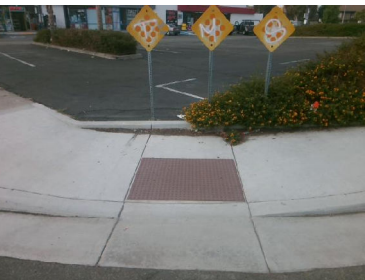
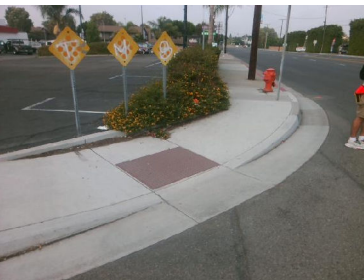
| Compliance | Description | Data | Compliance | Description | Data |
|---|---|---|---|---|---|
| <b>Yes</b> | Overall Surface Condition | <b>Acceptable</b> | | | |
