# Access Compliance Report Public Rights-of-Way (Curb Ramps)

Main Street: N\_PAMPAS\_ST Cross Street: LINCOLN\_AVE Location: SW

ADA ID: RPAT210924085207 Ramp Type: Type 1 - Perpendicular Diagonal Initial Pass/Fail: Pass Overall Compliance: No Severity Score: 0

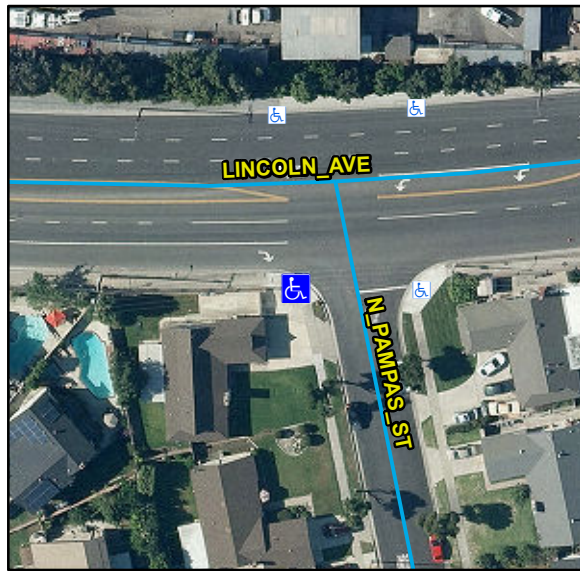
| Compliance | Description | Data | Compliance | Description | Data |
|---|---|---|---|---|---|
| Yes | Gutter Ponding | No | No | Curb Slope | 5.9 |
| No | Gutter Cross Slope (%) | 2.9 | | | |

Remove & Replace Curb Ramp With Two New Directional Ramps or Equivalent. Remove & Replace Gutter.

R304.2.2, R304.2.1, R304.5.3, STD 1115
