# Access Compliance Report Public Rights-of-Way (Curb Ramps)

Main Street: N\_PAMPAS\_ST Cross Street: CRYSTAL\_VIEW\_AVE Location: NE

ADA ID: RPAT210924090002 Ramp Type: Type 1 - Perpendicular Diagonal Initial Pass/Fail: Fail Overall Compliance: No Severity Score: 16

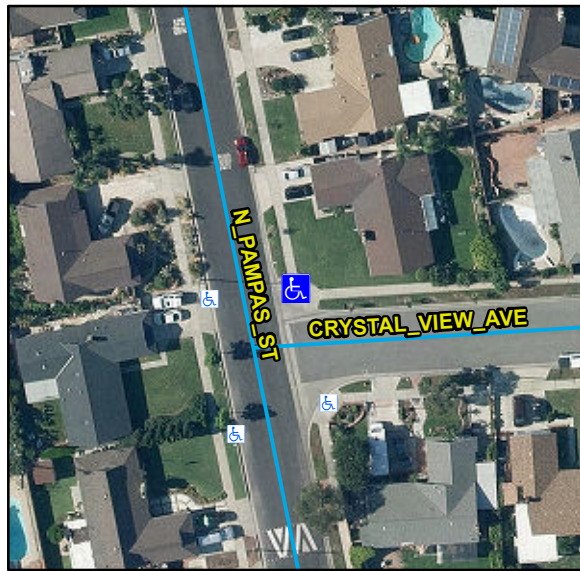
| Compliance | Description | Data | Compliance | Description | Data |
|---|---|---|---|---|---|
| No | Ramp Run Slope (%) | 8.7 | N/A | Flare Slope LT (%) | N/A |

Remove & Replace Curb Ramp With Two New Directional Ramps or Equivalent.

R304.2.2, STD 1115
