# Access Compliance Report Public Rights-of-Way (Curb Ramps)

Main Street: CRYSTAL\_VIEW\_AVE Cross Street: N\_PAMPAS\_ST Location: SE

ADA ID: RPAT210924090244 Ramp Type: Type 1 - Perpendicular Diagonal Initial Pass/Fail: Fail Overall Compliance: No Severity Score: 16

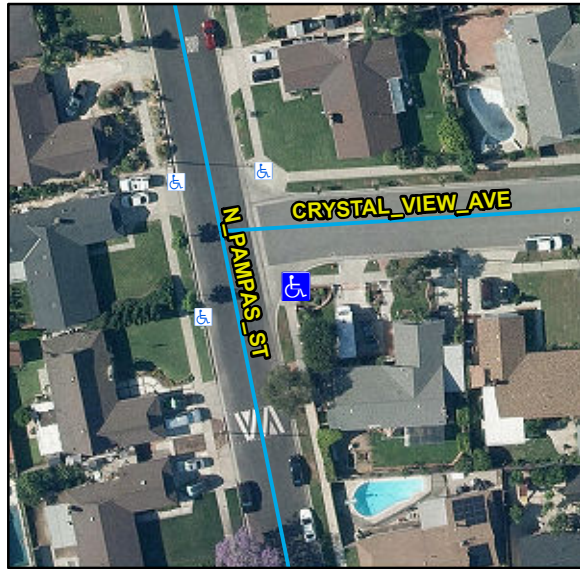
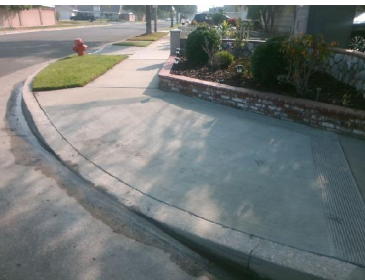
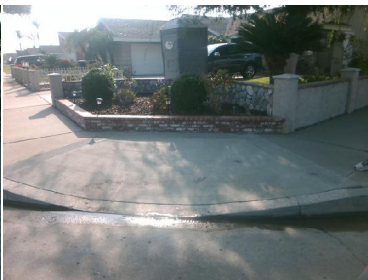
| Compliance | Description | Data | Compliance | Description | Data |
|---|---|---|---|---|---|
| No | Ramp Run Slope (%) | 10.2 | N/A | Flare Slope LT (%) | N/A |

Remove & Replace Curb Ramp With Two New Directional Ramps or Equivalent.

R304.2.2, STD 1115
