# Access Compliance Report Public Rights-of-Way (Curb Ramps)

Main Street: LINCOLN\_AVE Cross Street: BATAVIA\_ST Location: SE

ADA ID: RPAT210924091314 Ramp Type: Type 1 - Perpendicular Diagonal Initial Pass/Fail: Fail Overall Compliance: No Severity Score: 15

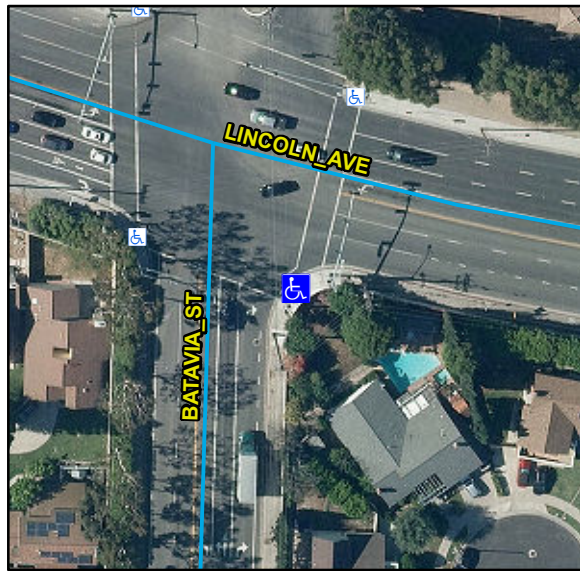
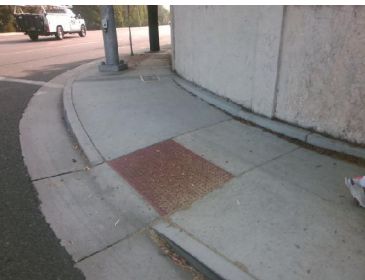
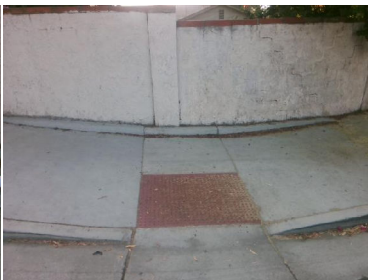
| Compliance | Description | Data | Compliance | Description | Data |
|---|---|---|---|---|---|
| No | Ramp Cross Slope (%) | 5.4 | N/A | Flare Traversable LT | N/A |
| N/A | Gutter Ponding | N/A | No | Curb Slope | 12.5 |

Remove & Replace Curb Ramp With Two New Directional Ramps or Equivalent.

R304.2.2, R304.5.3, STD 1115
