# Access Compliance Report Public Rights-of-Way (Curb Ramps)

Main Street: BATAVIA\_ST Cross Street: W\_DUNTON\_AVE Location: NE

ADA ID: RPAT210924092553 Ramp Type: Type 1 - Perpendicular Diagonal Initial Pass/Fail: Pass Overall Compliance: No Severity Score: 5

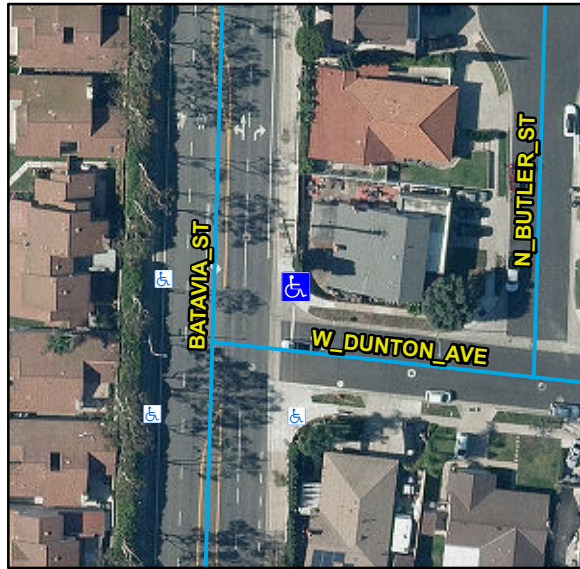
| Compliance | Description | Data | Compliance | Description | Data |
|---|---|---|---|---|---|
| Yes | Gutter Ponding | No | No | Curb Slope | 9.5 |
| No | Gutter Run Slope (%) | 5.4 | | Road Cross Slope (%) | 2.4 |

Remove & Replace Curb Ramp With Two New Directional Ramps or Equivalent. Remove & Replace Gutter.
