# Access Compliance Report Public Rights-of-Way (Curb Ramps)

Main Street: W\_DUNTON\_AVE Cross Street: BATAVIA\_ST Location: SE

ADA ID: RPAT210924093022 Ramp Type: Type 1 - Perpendicular Diagonal Initial Pass/Fail: Pass Overall Compliance: No Severity Score: 0

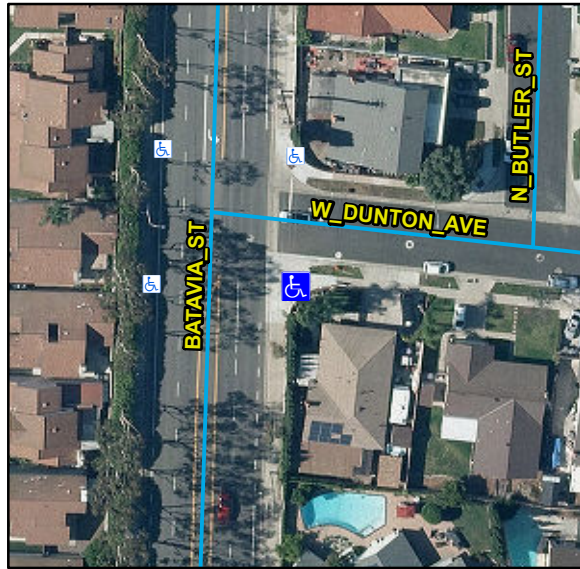
| Compliance | Description | Data | Compliance | Description | Data |
|---|---|---|---|---|---|
| No | Landing Cross Slope (%) | 2.2 | Yes | DWS Provided | Yes |

Remove & Replace Landing.

R304.2.1, R304.5.3, STD 1115
