# Access Compliance Report Public Rights-of-Way (Curb Ramps)

Main Street: N/A Cross Street: LINCOLN\_AVE Location: N

ADA ID: RPAT210924101747 Ramp Type: Type 7 - Directional 2 Initial Pass/Fail: Pass Overall Compliance: No Severity Score: 6

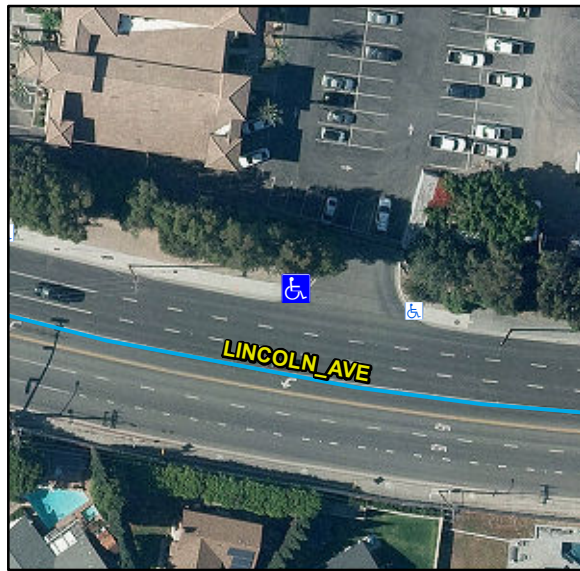
| Compliance | Description | Data | Compliance | Description | Data |
|---|---|---|---|---|---|
| No | Grade Break | No | Yes | Flare Type RT | |
| No | Landing Length (in) | 32 | Yes | DWS Length (in) | 36 |
| No | Gutter Cross Slope (%) | 5.4 | | Parallel Ramp Side | Right |

Remove & Replace Entire Ramp. Remove & Replace Gutter.
