# Access Compliance Report Public Rights-of-Way (Curb Ramps)

Main Street: N/A Cross Street: LINCOLN\_AVE Location: N

ADA ID: RPAT210924102309 Ramp Type: Type 7 - Directional 2 Initial Pass/Fail: Pass Overall Compliance: No Severity Score: 0

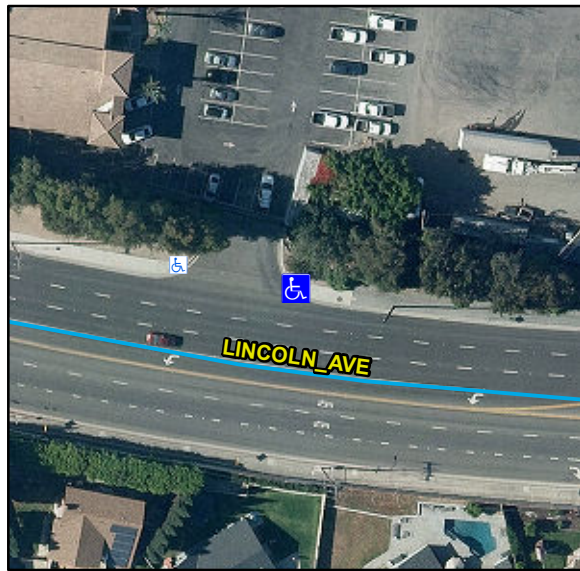
| Compliance | Description | Data | Compliance | Description | Data |
|---|---|---|---|---|---|
| No | Grade Break | No | N/A | Flare Type RT | |
| Yes | Gutter Ponding | No | Yes | Curb Slope | 5.6 |
| Yes | Gutter Lip Height (in) | 0 | | Road Run Slope (%) | N/A |
| Yes | Gutter Run Slope (%) | 5 | | Road Cross Slope (%) | N/A |
| Yes | Gutter Cross Slope (%) | 3 | | Parallel Ramp Side | Left |
| Yes | Overall Surface Condition | Acceptable | Yes | Perp Joint Present | Yes |

Possible Solutions:

Remove & Replace Entire Ramp.

OC Std/PROW:

R304.5.2, STD 1115
