# Access Compliance Report Public Rights-of-Way (Curb Ramps)

Main Street: LINCOLN\_AVE Cross Street: RIVERBEND\_PKWY Location: NW

ADA ID: RPAT210924102922 Ramp Type: Type 1 - Perpendicular Diagonal Initial Pass/Fail: Pass Overall Compliance: No Severity Score: 9

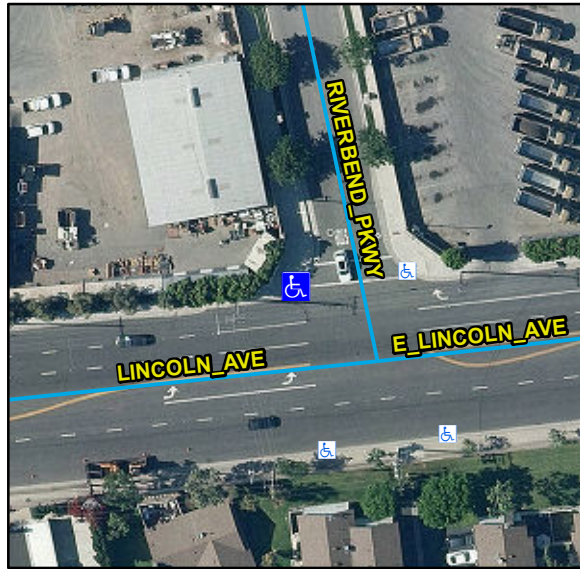
| Compliance | Description | Data | Compliance | Description | Data |
|---|---|---|---|---|---|
| Yes | Gutter Ponding | No | No | Curb Slope | 6.8 |
| No | Gutter Run Slope (%) | 7.6 | | Road Cross Slope (%) | 0.1 |

Remove & Replace Curb Ramp With Two New Directional Ramps or Equivalent. Remove & Replace Gutter.

R304.2.2, R304.2.1, R304.5.4, STD 1115
