# Access Compliance Report Public Rights-of-Way (Curb Ramps)

Main Street: COTTONWOOD\_ST Cross Street: LINCOLN\_AVE Location: NE

ADA ID: RPAT210924105330 Ramp Type: Type 1 - Perpendicular Diagonal Initial Pass/Fail: Pass Overall Compliance: No Severity Score: 4

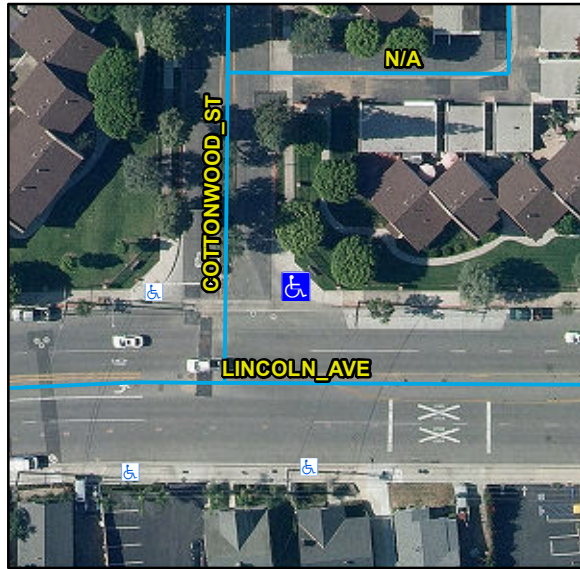
| Compliance | Description | Data | Compliance | Description | Data |
|---|---|---|---|---|---|
| Yes | Gutter Ponding | No | No | Curb Slope | 8.1 |

Remove & Replace Curb Ramp With Two New Directional Ramps or Equivalent.

R304.2.2, R304.2.1, STD 1115
