# Access Compliance Report Public Rights-of-Way (Curb Ramps)

Main Street: LINCOLN\_AVE Cross Street: COTTONWOOD\_ST Location: NW

ADA ID: RPAT210924105719 Ramp Type: Type 1 - Perpendicular Diagonal Initial Pass/Fail: Pass Overall Compliance: No Severity Score: 4

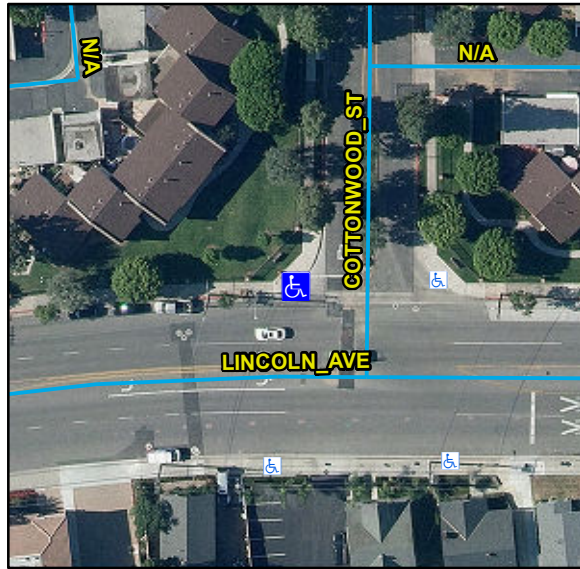
| Compliance | Description | Data | Compliance | Description | Data |
|---|---|---|---|---|---|
| Yes | Gutter Ponding | No | No | Curb Slope | 5.4 |

Remove & Replace Curb Ramp With Two New Directional Ramps or Equivalent.

R304.2.2, R304.2.1, STD 1115
