# Access Compliance Report Public Rights-of-Way (Curb Ramps)

Main Street: N\_GAYLE\_ST Cross Street: BIXBY\_AVE Location: NE

ADA ID: RPAT210924122156 Ramp Type: Type 1 - Perpendicular Diagonal Initial Pass/Fail: Fail Overall Compliance: No Severity Score: 16

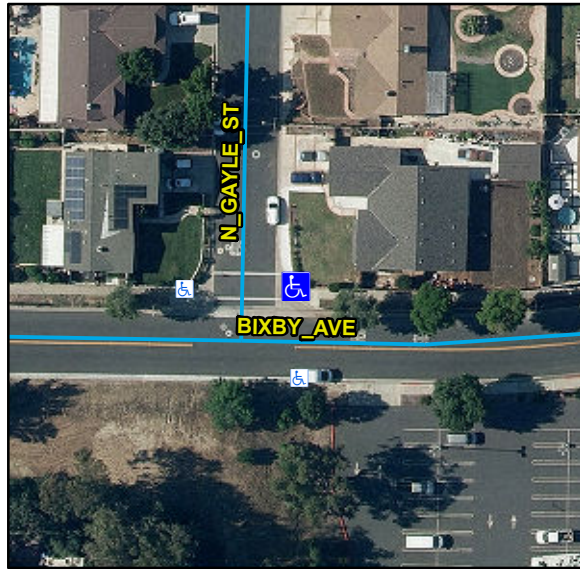
| Compliance | Description | Data | Compliance | Description | Data |
|---|---|---|---|---|---|
| No | Ramp Run Slope (%) | 8.8 | N/A | Flare Slope LT (%) | N/A |
| No | Ramp Cross Slope (%) | 5 | N/A | Flare Traversable LT | N/A |

**Remove & Replace Curb Ramp With Two New Directional Ramps or Equivalent. Restripe Crosswalk.**
