# Access Compliance Report Public Rights-of-Way (Curb Ramps)

Main Street: N\_OCEAN\_VIEW\_ST Cross Street: BIXBY\_AVE Location: NE

ADA ID: RPAT210924122642 Ramp Type: Type 6 - Directional 1 Initial Pass/Fail: Fail Overall Compliance: No Severity Score: 60

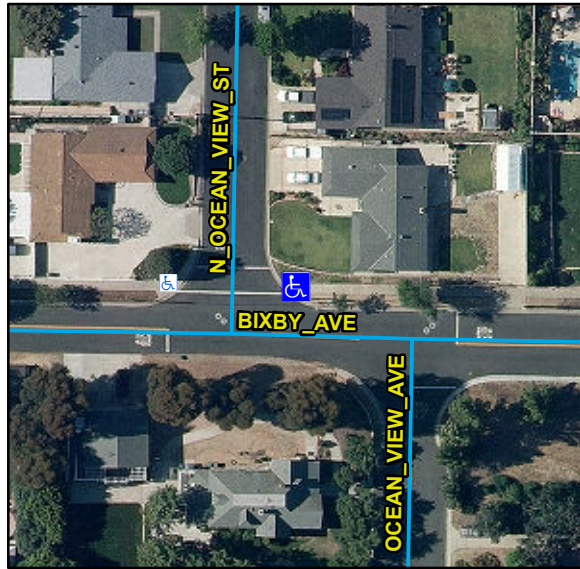
| Compliance | Description | Data | Compliance | Description | Data |
|---|---|---|---|---|---|
| No | Ramp Run Slope (%) | 13.4 | N/A | Flare Slope LT (%) | N/A |
| No | Ramp Cross Slope (%) | 8 | N/A | Flare Traversable LT | N/A |

Remove & Replace Entire Ramp. Restripe Crosswalk.

R204.3, R304.2.2, R304.5.3, STD 1115

Total Cost: \$ 7080
