# Access Compliance Report Public Rights-of-Way (Curb Ramps)

Main Street: N\_FAIRBAIRN\_ST Cross Street: BIXBY\_AVE Location: NE

ADA ID: RPAT210924123345 Ramp Type: Type 1 - Perpendicular Initial Pass/Fail: Fail Overall Compliance: No Severity Score: 32

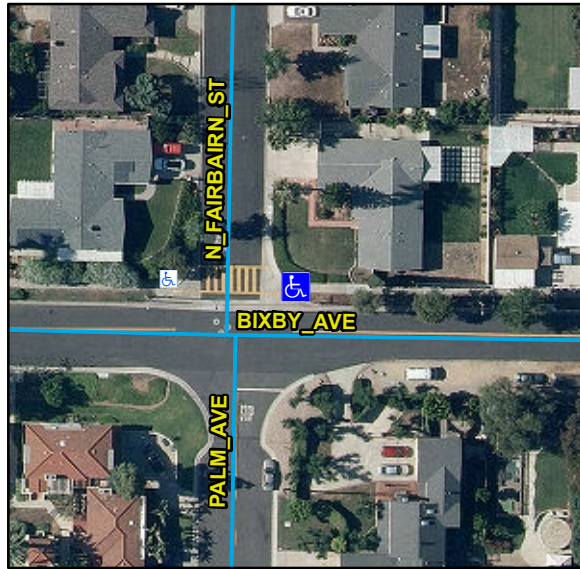
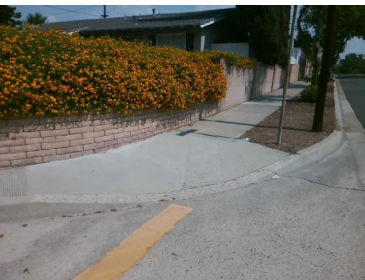
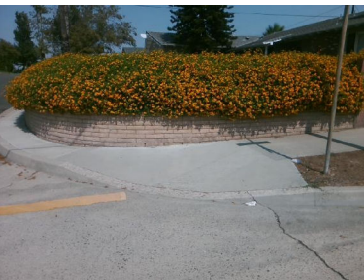
| Compliance | Description | Data | Compliance | Description | Data |
|---|---|---|---|---|---|
| No | Ramp Run Slope (%) | 15.1 | N/A | Flare Slope LT (%) | N/A |
| No | Ramp Cross Slope (%) | 5 | N/A | Flare Traversable LT | N/A |

Remove & Replace Entire Ramp. Restripe Crosswalk.
