# Access Compliance Report Public Rights-of-Way (Curb Ramps)

Main Street: N\_SHERI\_ST Cross Street: BIXBY\_AVE Location: NW

ADA ID: RPAT210924123640 Ramp Type: Type 6 - Directional 1 Initial Pass/Fail: Fail Overall Compliance: No Severity Score: 30

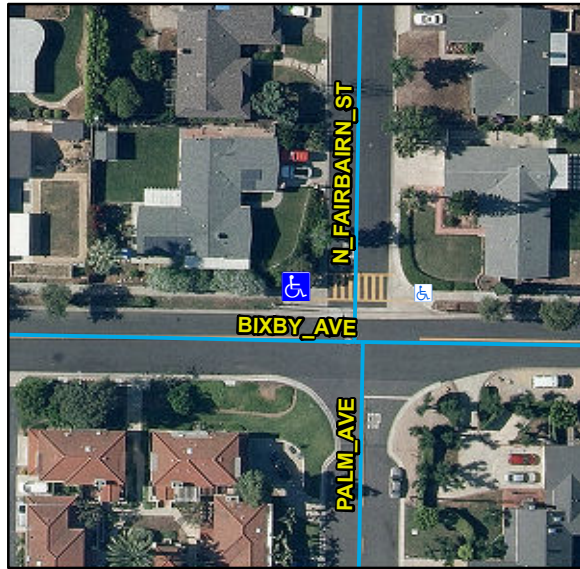
| Compliance | Description | Data | Compliance | Description | Data |
|---|---|---|---|---|---|
| No | Ramp Run Slope (%) | 8.9 | N/A | Flare Slope LT (%) | N/A |
| No | Ramp Cross Slope (%) | 5.6 | N/A | Flare Traversable LT | N/A |

Remove & Replace Entire Ramp. Restripe Crosswalk.

R204.3, R304.2.2, R304.5.3, STD 1115
