# Access Compliance Report Public Rights-of-Way (Curb Ramps)

Main Street: N\_SHERI\_ST Cross Street: BIXBY\_AVE Location: NE

ADA ID: RPAT210924124027 Ramp Type: Type 7 - Directional 2 Initial Pass/Fail: Fail Overall Compliance: No Severity Score: 30

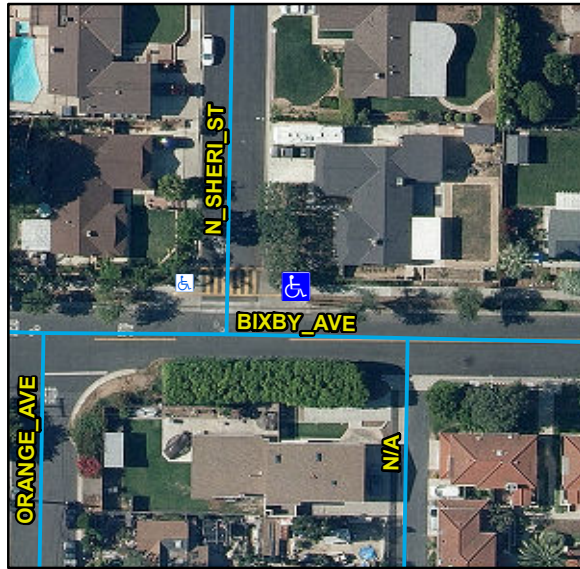
**R204.3, R304.2.2, R304.5.3, STD 1115**

| Compliance | Description | Data | Compliance | Description | Data |
|---|---|---|---|---|---|
| No | Ramp Run Slope (%) | 10.1 | N/A | Flare Slope LT (%) | N/A |
| No | Ramp Cross Slope (%) | 5.2 | N/A | Flare Traversable LT | N/A |

**Remove & Replace Entire Ramp. Restripe Crosswalk.**
