# Access Compliance Report Public Rights-of-Way (Curb Ramps)

Main Street: N\_SHERI\_ST Cross Street: BIXBY\_AVE Location: NW

ADA ID: RPAT210924124238 Ramp Type: Type 6 - Directional 1 Initial Pass/Fail: Fail Overall Compliance: No Severity Score: 5

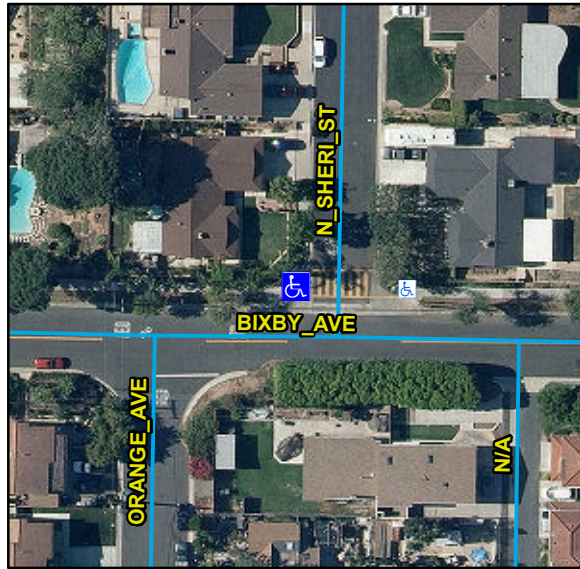
| Compliance | Description | Data | Compliance | Description | Data |
|---|---|---|---|---|---|
| No | Ramp Width (in) | 45 | | | N/A |
| No | Ramp Cross Slope (%) | 3.9 | N/A | Flare Traversable LT | N/A |

Remove & Replace Entire Ramp. Restripe Crosswalk.
