# Access Compliance Report Public Rights-of-Way (Curb Ramps)

Main Street: N\_SKYWOOD\_ST Cross Street: BIXBY\_AVE Location: NE

ADA ID: RPAT210924124726 Ramp Type: Type 6 - Directional 1 Initial Pass/Fail: Pass Overall Compliance: No Severity Score: 50

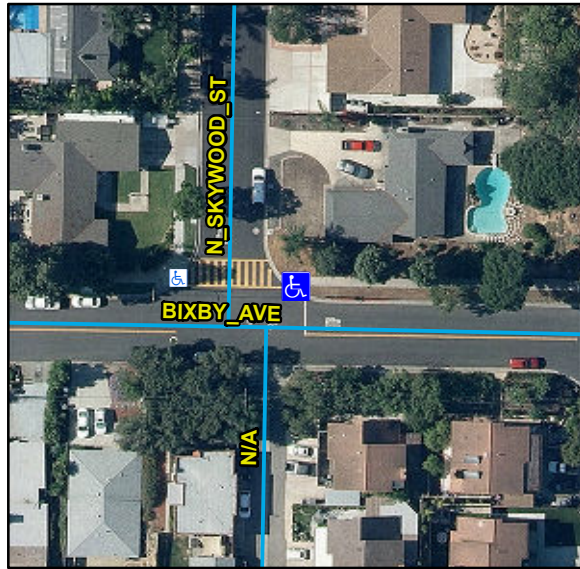
| Compliance | Description | Data | Compliance | Description | Data |
|---|---|---|---|---|---|
| No | Ramp Run Slope (%) | 23.5 | N/A | Flare Slope LT (%) | N/A |
| No | Grade Break | No | N/A | Flare Type RT | |
| N/A | Landing Present | No | N/A | DWS Contrast | N/A |
| No | Ramp Inside Crosswalk 1 | No | | | |
| No | Gutter Run Slope (%) | -9999 | | Road Cross Slope (%) | N/A |
| No | Gutter Cross Slope (%) | -9999 | | Parallel Ramp Side | N/A |

Remove & Replace Entire Ramp. Restripe Crosswalk. Remove & Replace Gutter.
