**Main Street:** MAGNOLIA\_AVE      **Cross Street:** BIXBY\_AVE      **Location:** NW

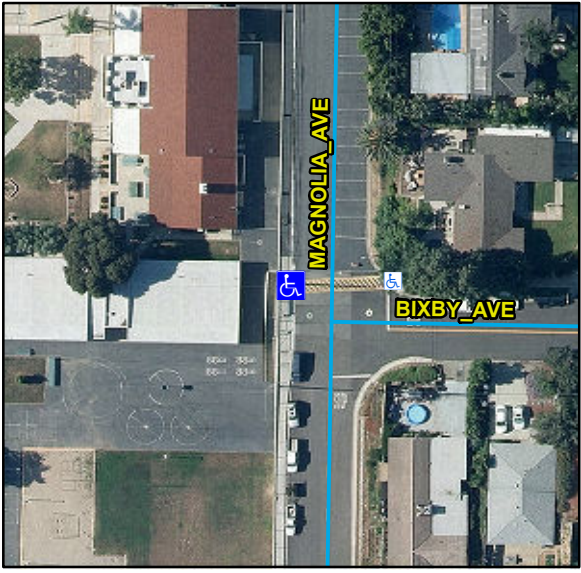
**ADA ID:** RPAT210924130141      **Ramp Type:** Type 4 - Parallel      **Initial Pass/Fail:** Fail      **Overall Compliance:** No      **Severity Score:** 16

Compliance	Description	Data	Compliance	Description	Data
N/A	Ramp Length LT (in)	72	N/A	Ramp Length RT (in)	73
Yes	Ramp Width LT (in)	83	Yes	Ramp Width RT (in)	83
No	Ramp Run Slope LT (%)	10.2	Yes	Ramp Run Slope RT (%)	7.1
Yes	Ramp Cross Slope LT (%)	0.8	Yes	Ramp Cross Slope RT (%)	2
N/A	Landing Present	N/A	N/A	DWS Provided	N/A
N/A	Landing Length (in)	N/A	N/A	DWS Contrast	N/A
N/A	Landing Width (in)	N/A	N/A	DWS Length (in)	N/A
N/A	Landing Run Slope (%)	N/A	N/A	DWS Full Width	N/A
N/A	Landing Cross Slope (%)	N/A		DWS Offset Type	N/A
N/A	Landing Movement Obstructed?	N/A	N/A	DWS Offset Left (in)	N/A
	Landing Movement Type	N/A	N/A	DWS Offset Right (in)	N/A
N/A	Landing Shared	N/A			
N/A	Clear Space	N/A			
N/A	Clear Space To Crosswalk (in)	N/A			
N/A	Marked Crosswalk 1	Yes	N/A	Marked Crosswalk 2	N/A
	Crossing 1 Direction	E		Crossing 2 Direction	N/A
N/A	Marked Crosswalk 1 Width (in)	84		Marked Crosswalk 2 Width (in)	N/A

N/A	Ramp Inside Crosswalk 1	Yes	N/A	Ramp Inside Crosswalk 2	N/A
	Crossing 1 Slope (%)	7.8		Crossing 2 Slope (%)	N/A
	Crossing 1 Cross Slope (%)	1.8		Crossing 2 Cross Slope (%)	N/A
N/A	Gutter Ponding	N/A	N/A	Curb Slope	12.4
Yes	Gutter Lip Height (in)	0		Road Run Slope (%)	N/A
N/A	Gutter Run Slope (%)	N/A		Road Cross Slope (%)	N/A
N/A	Gutter Cross Slope (%)	N/A	Yes	Perpendicular Joint Present	Yes
Yes	Overall Surface Condition	Acceptable		Spandrel Present?	No
	Cross Gutter Present?	No		Replace Spandrel?	N/A
	Replace Cross Gutter?	N/A

**Possible Solutions:**  
**Remove & Replace Entire Ramp.**

**OC Std/PROW:**  
**R304.3.2, STD 1115**

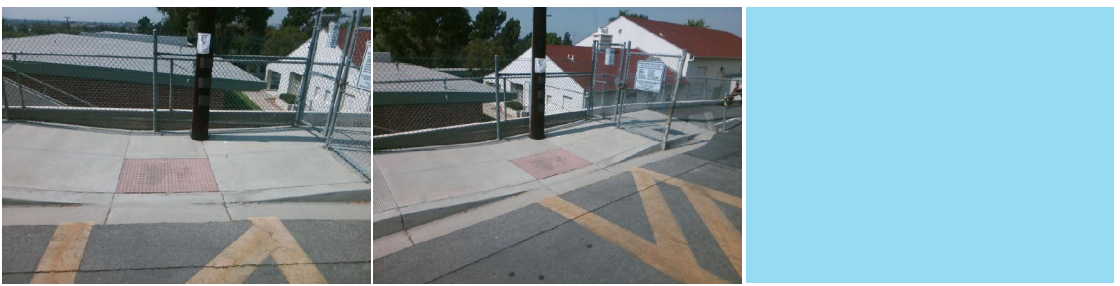
Compliance	Description	Data	Compliance	Description	Data
Yes	Obstructions Present?	No	N/A	Utilities Present?	No
	Obstruction Types	N/A		Utility Types	
	Obstruction Dimensions	N/A			N/A
