# Access Compliance Report Public Rights-of-Way (Curb Ramps)

Main Street: PALM\_AVE Cross Street: LINCOLN\_AVE Location: NE

ADA ID: RPAT210924134613 Ramp Type: Type 7 - Directional 2 Initial Pass/Fail: Pass Overall Compliance: No Severity Score: 0

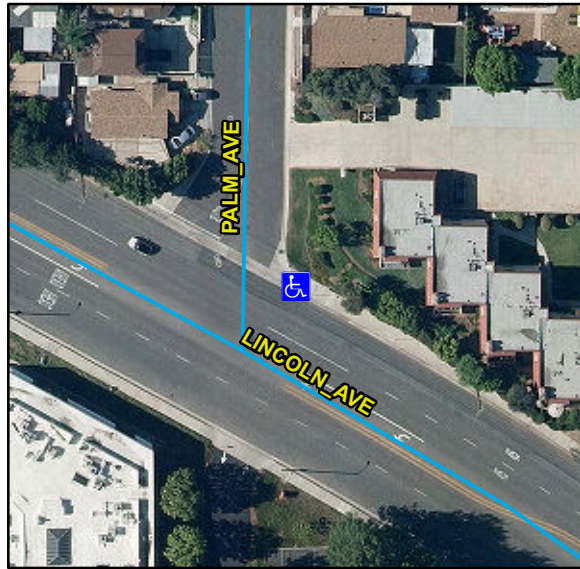
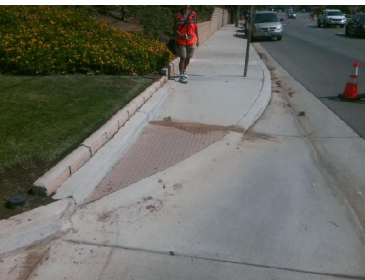
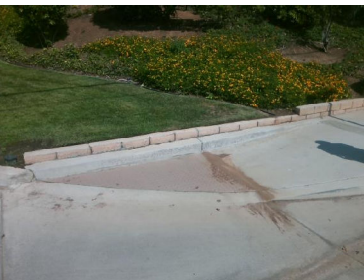
R304.2.2, R304.2.1, R304.5.2, STD 1115

| Compliance | Description | Data | Compliance | Description | Data |
|---|---|---|---|---|---|
| No | Grade Break | No | N/A | Flare Type RT | |
| No | Landing Length (in) | 53 | Yes | DWS Length (in) | 36 |
| Yes | Gutter Ponding | No | No | Curb Slope | 9.1 |

Remove & Replace Entire Ramp.
