# Access Compliance Report Public Rights-of-Way (Curb Ramps)

Main Street: OLIVE\_AVE Cross Street: LINCOLN\_AVE Location: NE

ADA ID: RPAT210924135806 Ramp Type: Type 1 - Perpendicular Initial Pass/Fail: Fail Overall Compliance: No Severity Score: 15

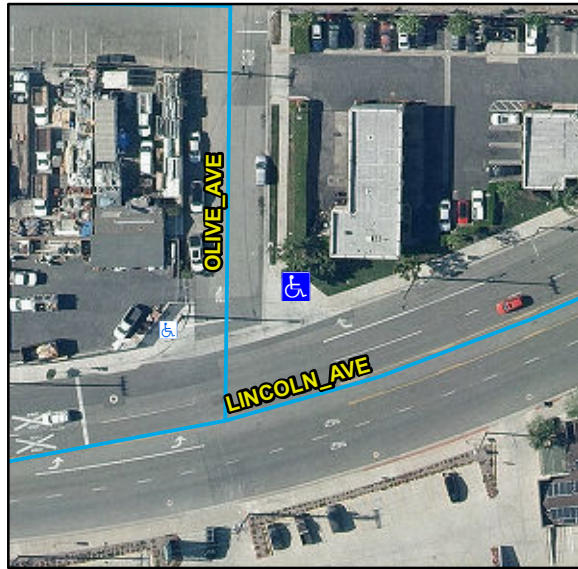
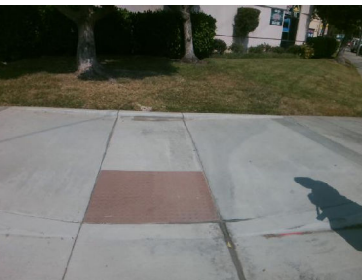
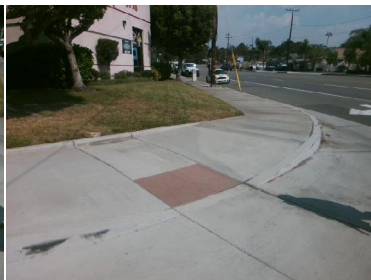
R304.2.2, STD 1115

| Compliance | Description | Data | Compliance | Description | Data |
|---|---|---|---|---|---|
| No | Ramp Run Slope (%) | 8.5 | N/A | Flare Slope LT (%) | N/A |

Remove & Replace Entire Ramp.
