# Access Compliance Report Public Rights-of-Way (Curb Ramps)

| Main Street: LINCOLN_AVE | | Cross Street: OLIVE_AVE | | Location: | NW |
| ADA ID: RPAT210924140001 | Ramp Type:Type 1 - Perpendicular | Initial Pass/Fail: Pass | Overall Compliance: No | Severity Score: | 4 |

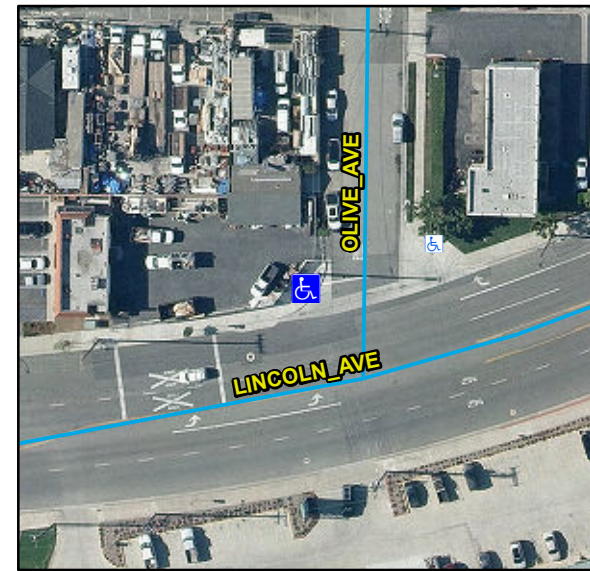
| Compliance | Description | Data | Compliance | Description | Data |
|---|---|---|---|---|---|
| N/A | Landing Movement Obstructed? | Yes | Yes | DWS Contrast | Yes |
| | Landing Movement Type | fence | Yes | DWS Length (in) | 36 |

Possible Solutions:

Remove & Replace Landing.

R304.2.1, STD 1115
