# Access Compliance Report Public Rights-of-Way (Curb Ramps)

Main Street: N\_ORANGE\_OLIVE\_RD Cross Street: LINCOLN\_AVE Location: NE

ADA ID: RPAT210924140436 Ramp Type: Type 1 - Perpendicular Diagonal Initial Pass/Fail: Pass Overall Compliance: No Severity Score: 9

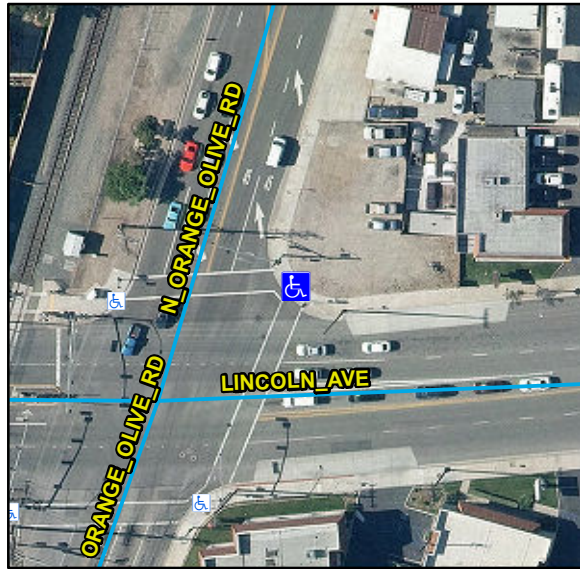
| Compliance | Description | Data | Compliance | Description | Data |
|---|---|---|---|---|---|
| Yes | Gutter Ponding | No | No | Curb Slope | 9.2 |
| No | Gutter Run Slope (%) | 8.9 | | Road Cross Slope (%) | 1.7 |

Remove & Replace Curb Ramp With Two New Directional Ramps or Equivalent. Remove & Replace Gutter.

R304.2.2, R304.2.1, R304.5.4, STD 1115
