# Access Compliance Report Public Rights-of-Way (Curb Ramps)

Main Street: LINCOLN\_AVE Cross Street: N\_ORANGE\_OLIVE\_RD Location: NW

ADA ID: RPAT210924141253 Ramp Type: Type 1 - Perpendicular Initial Pass/Fail: Fail Overall Compliance: No Severity Score: 15

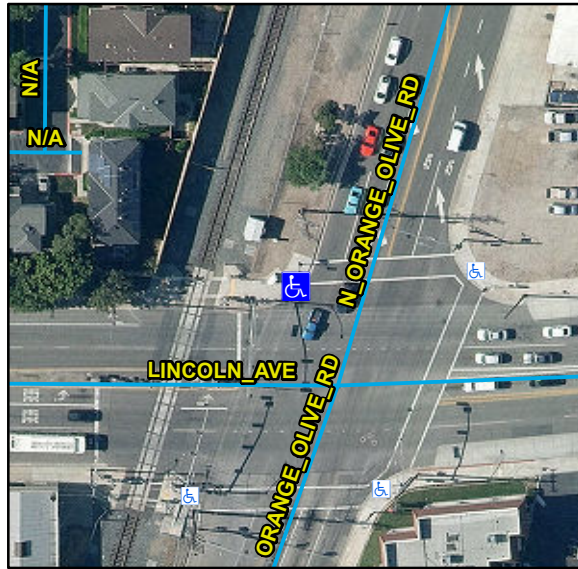
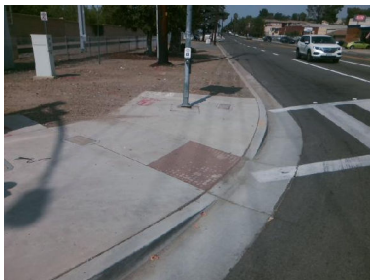
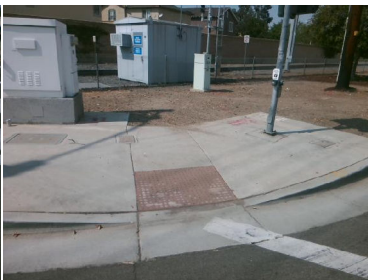
| Compliance | Description | Data | Compliance | Description | Data |
|---|---|---|---|---|---|
| No | Ramp Run Slope (%) | 9.4 | N/A | Flare Slope LT (%) | N/A |
| N/A | Gutter Ponding | N/A | No | Curb Slope | 10.3 |

Remove & Replace Entire Ramp.

R304.2.2, STD 1115
