# Access Compliance Report Public Rights-of-Way (Curb Ramps)

Main Street: ORANGE\_OLIVE\_RD Cross Street: E\_WHITECAP\_AVE Location: NE

ADA ID: RPAT210924142603 Ramp Type: Type 3 - Combination 1 Initial Pass/Fail: Pass Overall Compliance: No Severity Score: 0

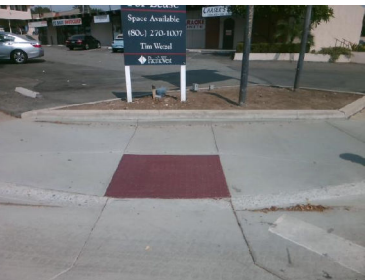
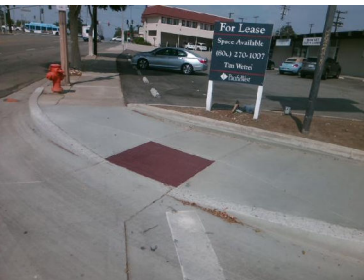
| Compliance | Description | Data | Compliance | Description | Data |
|---|---|---|---|---|---|
| Yes | Gutter Ponding | No | No | Curb Slope | 8.9 |

Remove & Replace Curb Slope.

R304.2.2, STD 1115
