Access Compliance Report Public Rights-of-Way (Curb Ramps)

Main Street: **E_WHITECAP_AVE** Cross Street: **ORANGE_OLIVE_RD** Location: **SE**

ADA ID: **RPAT210924143039** Ramp Type: **Type 1 - Perpendicular** Initial Pass/Fail: **Pass** Overall Compliance: **No** Severity Score: **0**

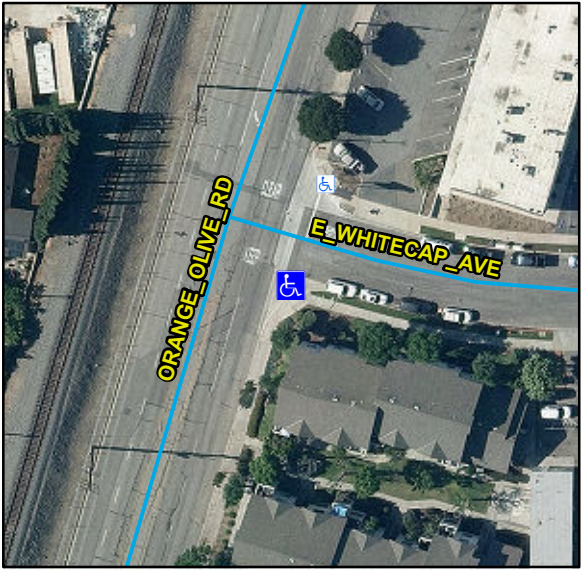
Compliance	Description	Data	Compliance	Description	Data
N/A	Ramp Length (in)	41	N/A	Flare Type LT	
Yes	Ramp Width (in)	49		Flare Slope LT (%)	Sloped
Yes	Ramp Run Slope (%)	7.6	N/A	Flare Traversable LT	8.4
Yes	Ramp Cross Slope (%)	2	N/A	Flare Type RT	No
N/A	Landing Present	Yes		Flare Slope RT (%)	Sloped
N/A	Landing Length (in)	50		Flare Traversable RT	Yes
Yes	Landing Width (in)	48	Yes	DWS Provided	Yes
Yes	Landing Run Slope (%)	1	N/A	DWS Contrast	Yes
Yes	Landing Cross Slope (%)	1.4	Yes	DWS Length (in)	36
N/A	Landing Movement Obstructed?	Yes	Yes	DWS Full Width	Yes
	Landing Movement Type	Curb	Yes	DWS Offset Left (in)	0
N/A	Landing Shared	No	Yes	DWS Offset Right (in)	N/A
N/A	Clear Space	N/A	Yes	Marked Crosswalk 1	N/A
N/A	Clear Space To Crosswalk (in)	N/A	N/A	Crossing 1 Direction	N/A
N/A	Marked Crosswalk 1	No	N/A	Marked Crosswalk 2	N/A
	Crossing 1 Width (in)	N/A		Crossing 1 Slope (%)	1.7
N/A	Ramp Inside Crosswalk 1	N/A	Yes	Crossing 1 Cross Slope (%)	2.3

Crossing 2 Width (in)	N/A	No	Gutter Ponding	No
	Crossing 2 Slope (%)	N/A	No	Gutter Lip Height (in)	0
	Crossing 2 Cross Slope (%)	N/A	Yes	Gutter Run Slope (%)	3.8
Yes	Gutter Ponding	No	No	Gutter Cross Slope (%)	1.6
Yes	Gutter Lip Height (in)	0		Overall Surface Condition: Acceptable	Yes
Yes	Gutter Run Slope (%)	3.8		Cross Gutter Present?	Yes
Yes	Gutter Cross Slope (%)	1.6		Replace Cross Gutter?	No
	Overall Surface Condition: Acceptable		Yes	Perp Joint Present	Yes
	Replace Cross Gutter?	No		Spandrel Present?	Yes
				Replace Spandrel?	No

Possible Solutions:
Remove & Replace Entire Ramp.

OC Std/PROW:
R304.2.2, R304.2.1, STD 1115
