# Access Compliance Report Public Rights-of-Way (Curb Ramps)

Main Street: MAIN\_ST Cross Street: N\_ORANGE\_OLIVE\_RD Location: SE

ADA ID: RPAT210924143731 Ramp Type: Type 6 - Directional 1 Initial Pass/Fail: Pass Overall Compliance: No Severity Score: 5

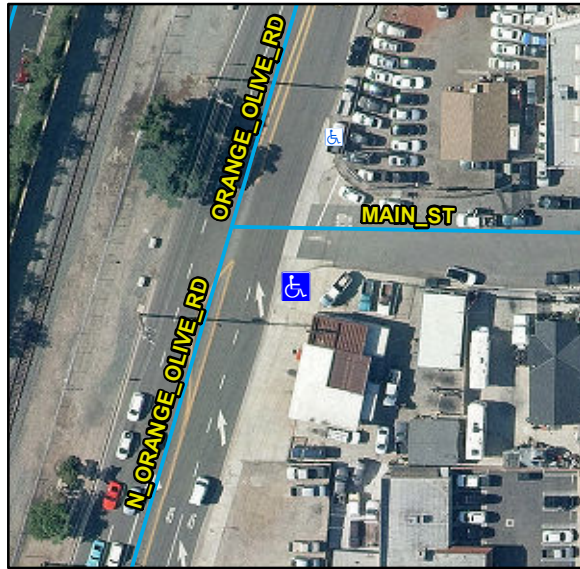
| Compliance | Description | Data | Compliance | Description | Data |
|---|---|---|---|---|---|
| No | Grade Break | No | N/A | Flare Type RT | |
| No | Gutter Run Slope (%) | 10.5 | | Road Cross Slope (%) | N/A |
| No | Gutter Cross Slope (%) | 2.8 | | Parallel Ramp Side | Left |

Remove & Replace Entire Ramp. Remove & Replace Gutter.
