# Access Compliance Report Public Rights-of-Way (Curb Ramps)

Main Street: E\_BUENA\_VISTA\_ST Cross Street: ORANGE\_OLIVE\_RD Location: SE

ADA ID: RPAT210924144330 Ramp Type: Type 4 - Parallel Initial Pass/Fail: Pass Overall Compliance: Yes Severity Score: 0

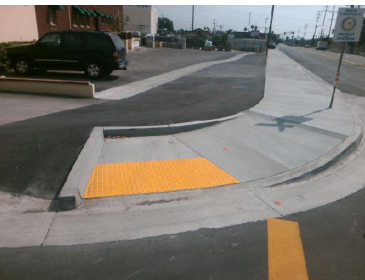
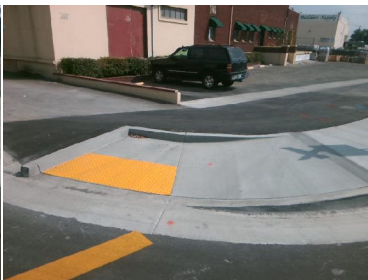
| Compliance | Description | Data | Compliance | Description | Data |
|---|---|---|---|---|---|
| Yes | Overall Surface Condition | Acceptable | | | |
