# Access Compliance Report Public Rights-of-Way (Curb Ramps)

| Main Street: OLIVE_AVE | | Cross Street: E_BUENA_VISTA_ST | | Location: | NW |
| ADA ID: RPAT210924145225 | Ramp Type: Type 7 - Directional 2 | Initial Pass/Fail: Fail | Overall Compliance: No | Severity Score: | 30 |

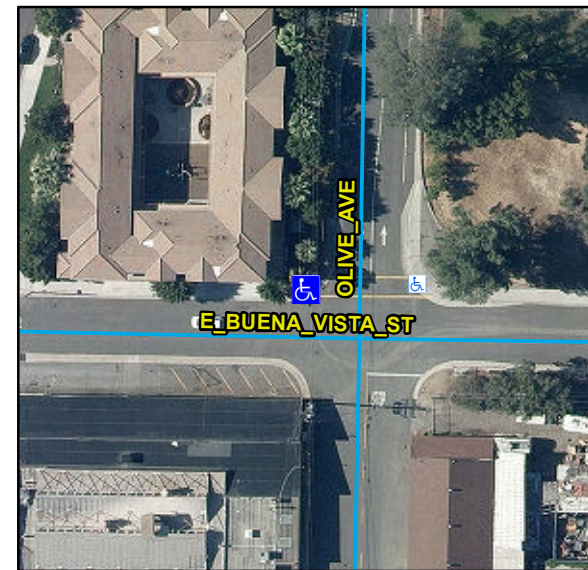
| Compliance | Description | Data | Compliance | Description | Data |
|---|---|---|---|---|---|
| No | Ramp Run Slope (%) | 9.1 | N/A | Flare Slope LT (%) | N/A |
| No | Ramp Cross Slope (%) | 6.9 | N/A | Flare Traversable LT | N/A |

Possible Solutions:

Remove & Replace Entire Ramp.

R304.2.2, R304.5.3, STD 1115

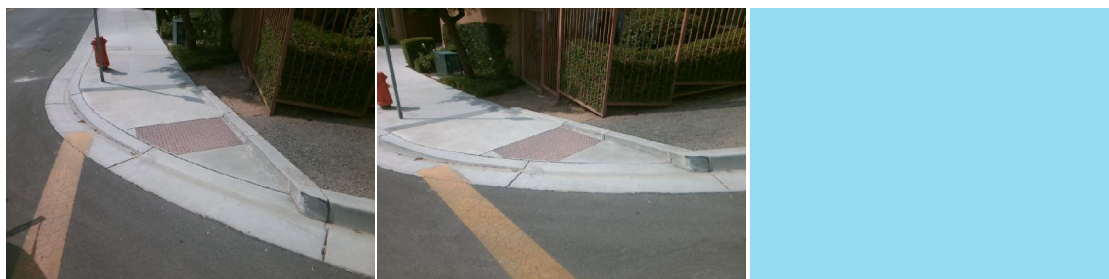
## Obstruction and Utility Measurement/Component Compliance

| Compliance | Description | Data | Compliance | Description | Data |
|---|---|---|---|---|---|
| Yes | Obstructions Present? | No | N/A | Utilities Present? | No |
| | Obstruction Types | N/A | | Utility Types | |
| | Obstruction Dimensions | N/A | | | N/A |
