# Access Compliance Report Public Rights-of-Way (Curb Ramps)

| Main Street: CLE GRANDE | | Cross Street: CHAPMAN_AVE | | Location: | SW |
| ADA ID: RPAT210927090219 | Ramp Type: Type 4 - Parallel | Initial Pass/Fail: Fail | Overall Compliance: No | Severity Score: | 19 |

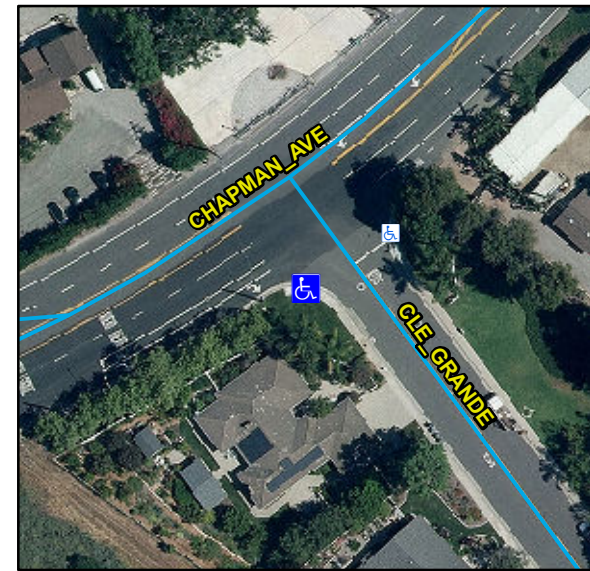
| Compliance | Description | Data | Compliance | Description | Data |
|---|---|---|---|---|---|
| No | Ramp Width LT (in) | 42 | No | Ramp Width RT (in) | 42 |
| No | Overall Surface Condition | Poor | | | |

Remove & Replace Entire Ramp.

R304.5.1, R302.7, STD 1115

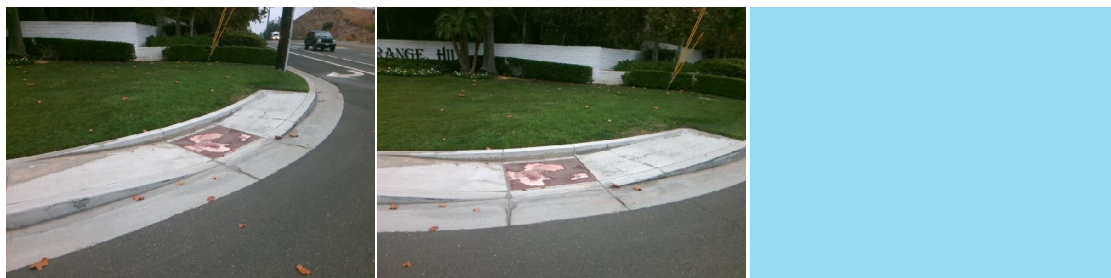
| Compliance | Description | Data | Compliance | Description | Data |
|---|---|---|---|---|---|
| N/A | Ramp Length LT (in) | 88 | N/A | Ramp Length RT (in) | 113 |
| Yes | Ramp Run Slope LT (%) | 5 | Yes | Ramp Run Slope RT (%) | 6.9 |
| Yes | Ramp Cross Slope LT (%) | 0.7 | Yes | Ramp Cross Slope RT (%) | 1.8 |
