# Access Compliance Report Public Rights-of-Way (Curb Ramps)

Main Street: CLE GRANDE Cross Street: CHAPMAN\_AVE Location: SE

ADA ID: RPAT210927090823 Ramp Type: Type 4 - Parallel Initial Pass/Fail: Fail Overall Compliance: No Severity Score: 19

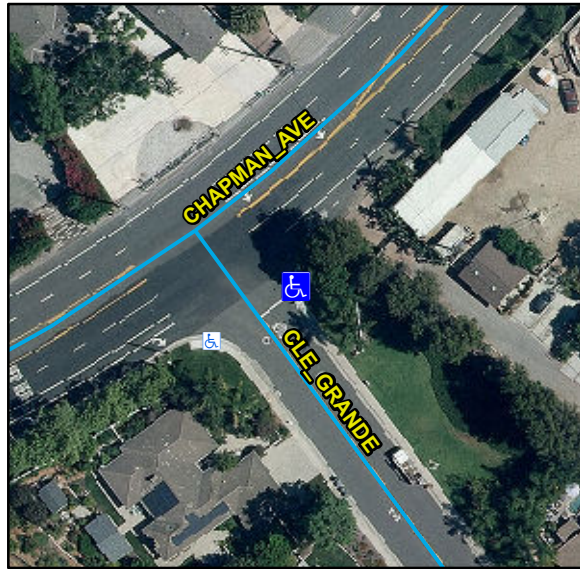
| Compliance | Description | Data | Compliance | Description | Data |
|---|---|---|---|---|---|
| N/A | Ramp Length LT (in) | 126 | N/A | Ramp Length RT (in) | 125 |
| No | Ramp Width LT (in) | 43 | No | Ramp Width RT (in) | 43 |
| Yes | Ramp Run Slope LT (%) | 2.3 | No | Ramp Run Slope RT (%) | 8.6 |

Remove & Replace Entire Ramp.

R304.5.1, R304.3.2, STD 1115
