# Access Compliance Report Public Rights-of-Way (Curb Ramps)

Main Street: CHAPMAN\_AVE Cross Street: ORANGE\_PARK\_BLVD Location: SW

ADA ID: RPAT210927091805 Ramp Type: Type 4 - Parallel Initial Pass/Fail: Fail Overall Compliance: No Severity Score: 16

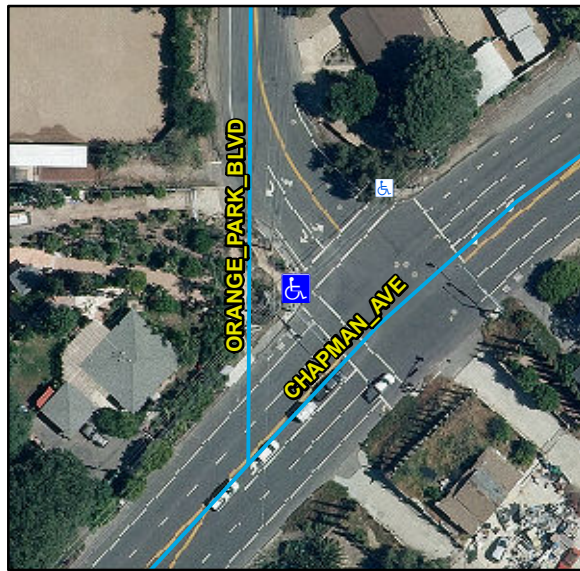
| Compliance | Description | Data | Compliance | Description | Data |
|---|---|---|---|---|---|
| Yes | Ramp Run Slope LT (%) | 5.7 | Yes | Ramp Run Slope RT (%) | 7.1 |
| No | Ramp Cross Slope LT (%) | 4.5 | No | Ramp Cross Slope RT (%) | 3.9 |
| No | Overall Surface Condition | Poor | | | |

Remove & Replace Curb Ramp With Two New Directional Ramps or Equivalent.

R304.5.3, R302.7, STD 1115

Total Cost: \$ 4000
