# Access Compliance Report Public Rights-of-Way (Curb Ramps)

Main Street: E\_CENTER\_ST Cross Street: EARLHAM\_ST Location: SE

ADA ID: RPAT210927103928 Ramp Type: Type 4 - Parallel Initial Pass/Fail: Fail Overall Compliance: No Severity Score: 5

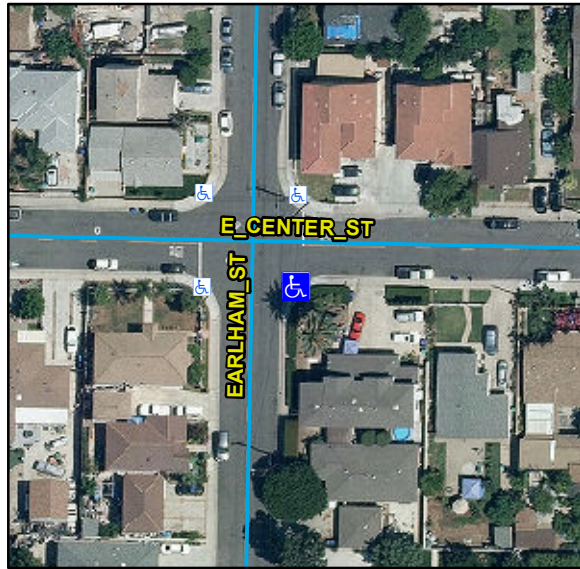
| Compliance | Description | Data | Compliance | Description | Data |
|---|---|---|---|---|---|
| Yes | Ramp Width LT (in) | 48 | No | Ramp Width RT (in) | 47 |
| No | Ramp Cross Slope LT (%) | 2.2 | Yes | Ramp Cross Slope RT (%) | 0.7 |

**Remove & Replace Curb Ramp With Two New Directional Ramps or Equivalent.**

**R304.5.1, R304.5.3, STD 1115**
