# Access Compliance Report Public Rights-of-Way (Curb Ramps)

Main Street: EARLHAM\_ST Cross Street: E\_CENTER\_ST Location: NE

ADA ID: RPAT210927104214 Ramp Type: Type 4 - Parallel Initial Pass/Fail: Fail Overall Compliance: No Severity Score: 19

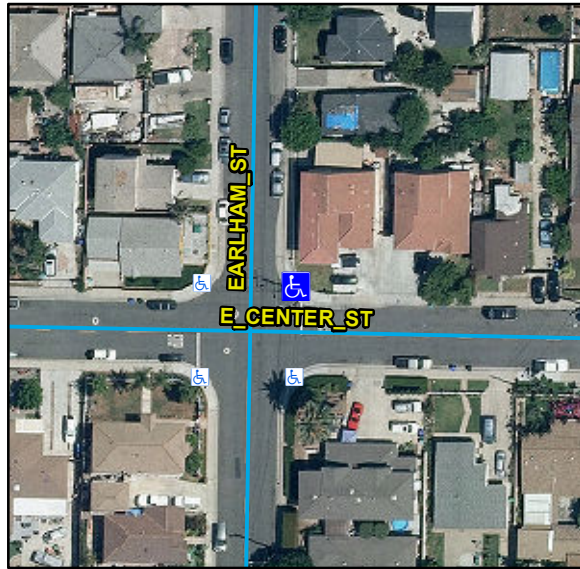
| Compliance | Description | Data | Compliance | Description | Data |
|---|---|---|---|---|---|
| No | Obstructions Present? | Yes | N/A | Utilities Present? | No |
| | Obstruction Types | Power Pole | | Utility Types | |

| Compliance | Description | Data | Compliance | Description | Data |
|---|---|---|---|---|---|
| No | Ramp Width LT (in) | 47 | Yes | Ramp Width RT (in) | 48 |
| Yes | Ramp Run Slope LT (%) | 4.8 | No | Ramp Run Slope RT (%) | 10.1 |

**Remove & Replace Curb Ramp With Two New Directional Ramps or Equivalent.**

**R304.5.1, R304.3.2, R302.3, R402.2, STD 1115**
