# Access Compliance Report Public Rights-of-Way (Curb Ramps)

Main Street: E\_CENTER\_ST Cross Street: EARLHAM\_ST Location: NW

ADA ID: RPAT210927104501 Ramp Type: Type 4 - Parallel Initial Pass/Fail: Fail Overall Compliance: No Severity Score: 5

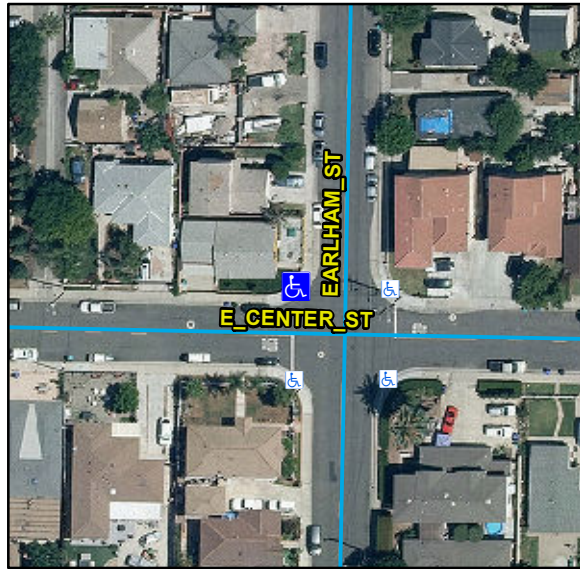
| Compliance | Description | Data | Compliance | Description | Data |
|---|---|---|---|---|---|
| No | Ramp Width LT (in) | 47 | Yes | Ramp Width RT (in) | 48 |
| Yes | Ramp Cross Slope LT (%) | 1.1 | No | Ramp Cross Slope RT (%) | 2.6 |

**Remove & Replace Curb Ramp With Two New Directional Ramps or Equivalent.**

**R304.5.1, R304.5.3, STD 1115**
