# Access Compliance Report Public Rights-of-Way (Curb Ramps)

Main Street: EARLHAM\_ST Cross Street: E\_VINE\_ST Location: SW

ADA ID: RPAT210927104924 Ramp Type: Type 4 - Parallel Initial Pass/Fail: Fail Overall Compliance: No Severity Score: 4

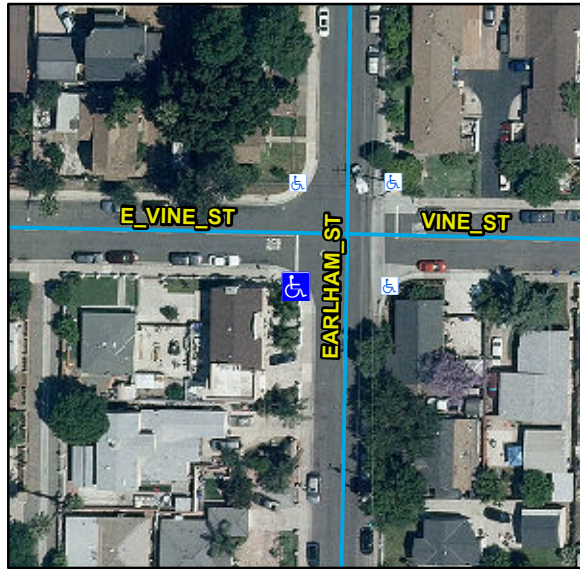
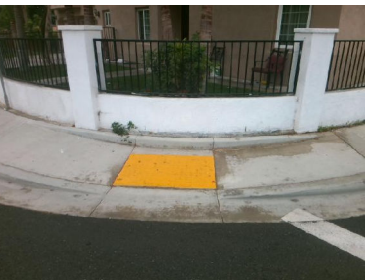
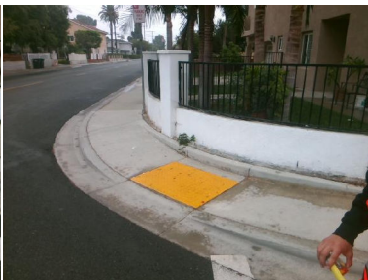
| Compliance | Description | Data | Compliance | Description | Data |
|---|---|---|---|---|---|
| Yes | Ramp Width LT (in) | 48 | No | Ramp Width RT (in) | 47 |

**Remove & Replace Curb Ramp With Two New Directional Ramps or Equivalent.**

**R304.5.1, STD 1115**
