# Access Compliance Report Public Rights-of-Way (Curb Ramps)

Main Street: VINE\_ST Cross Street: EARLHAM\_ST Location: SE

ADA ID: RPAT210927105253 Ramp Type: Type 4 - Parallel Initial Pass/Fail: Fail Overall Compliance: No Severity Score: 16

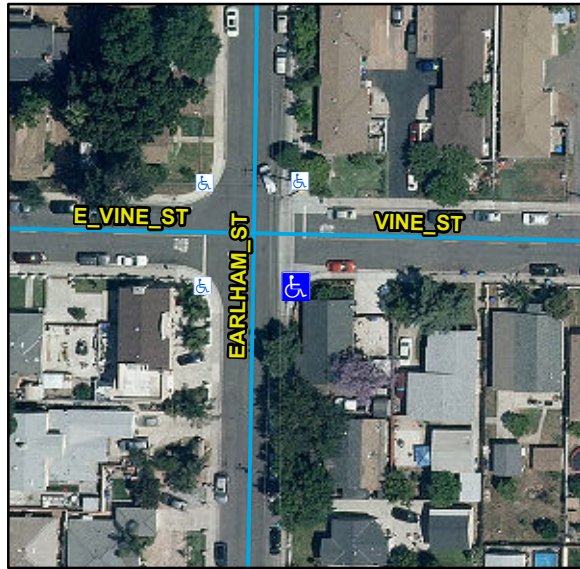
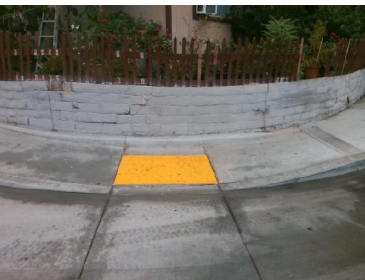
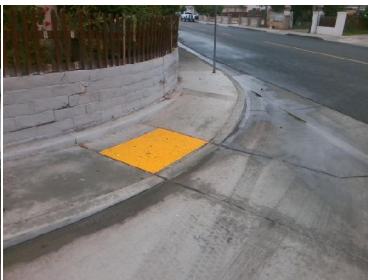
| Compliance | Description | Data | Compliance | Description | Data |
|---|---|---|---|---|---|
| No | Ramp Run Slope LT (%) | 10.1 | Yes | Ramp Run Slope RT (%) | 5.2 |

**Remove & Replace Curb Ramp With Two New Directional Ramps or Equivalent.**

**R304.3.2, STD 1115**

Total Cost: \$ 4000
