# Access Compliance Report Public Rights-of-Way (Curb Ramps)

Main Street: EARLHAM\_ST Cross Street: VINE\_ST Location: NE

ADA ID: RPAT210927105639 Ramp Type: Type 4 - Parallel Initial Pass/Fail: Fail Overall Compliance: No Severity Score: 4

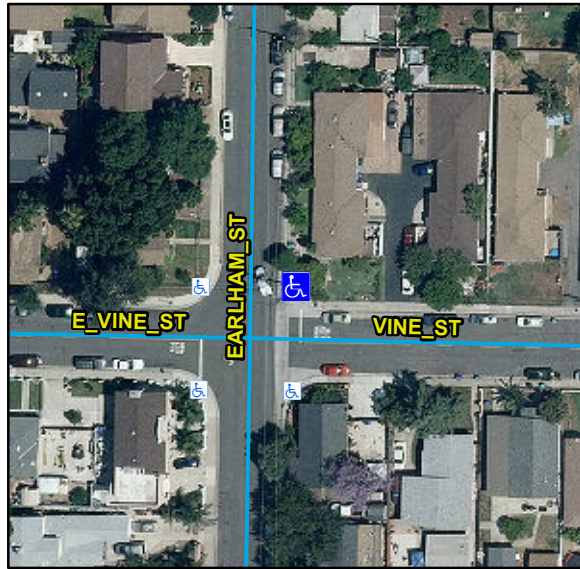
| Compliance | Description | Data | Compliance | Description | Data |
|---|---|---|---|---|---|
| No | Ramp Width LT (in) | 45 | Yes | Ramp Width RT (in) | 48 |

**Remove & Replace Curb Ramp With Two New Directional Ramps or Equivalent.**

**R304.5.1, STD 1115**
