# Access Compliance Report Public Rights-of-Way (Curb Ramps)

| Main Street: E_VINE_ST | | Cross Street: EARLHAM_ST | | Location: | NW |
| ADA ID: RPAT210927110111 | Ramp Type: Type 4 - Parallel | Initial Pass/Fail: Fail | Overall Compliance: No | Severity Score: | 4 |

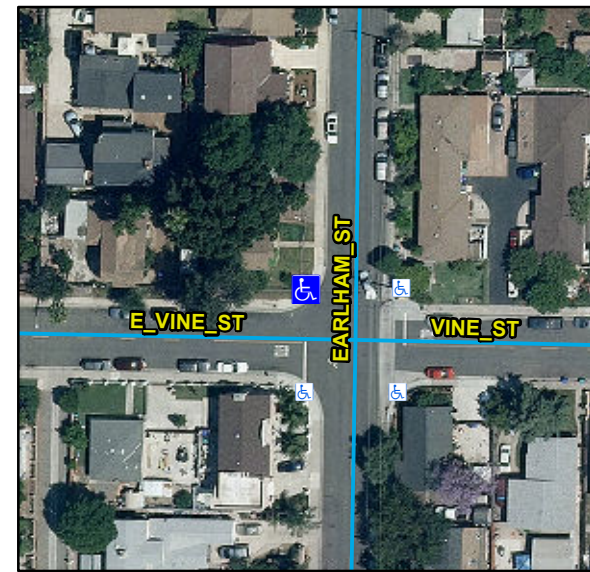
**R304.5.1, STD 1115**

| Compliance | Description | Data | Compliance | Description | Data |
|---|---|---|---|---|---|
| No | Ramp Width LT (in) | 47 | Yes | Ramp Width RT (in) | 48 |

**Remove & Replace Curb Ramp With Two New Directional Ramps or Equivalent.**

Total Cost: \$ 4000
