# Access Compliance Report Public Rights-of-Way (Curb Ramps)

Main Street: EARLHAM\_ST Cross Street: SPRING\_ST Location: SW

ADA ID: RPAT210927110538 Ramp Type: Type 4 - Parallel Initial Pass/Fail: Fail Overall Compliance: No Severity Score: 19

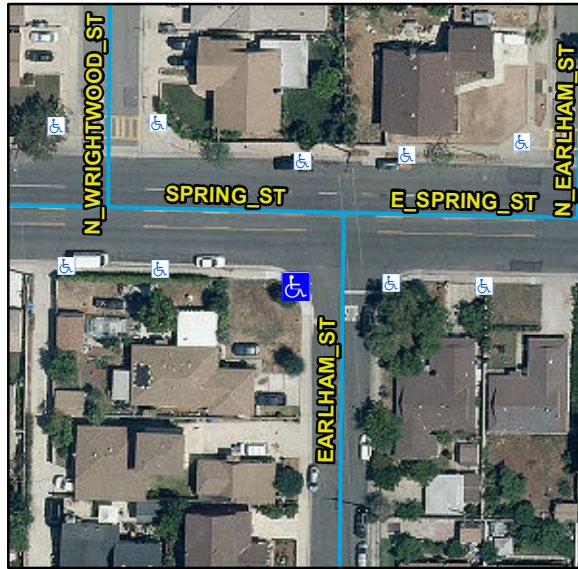
| Compliance | Description | Data | Compliance | Description | Data |
|---|---|---|---|---|---|
| No | Ramp Width LT (in) | 47 | No | Ramp Width RT (in) | 47 |
| Yes | Ramp Run Slope LT (%) | 5.4 | No | Ramp Run Slope RT (%) | 8.7 |

Remove & Replace Curb Ramp With Two New Directional Ramps or Equivalent.

R304.5.1, R304.3.2, STD 1115

Total Cost: \$ 4000
