# Access Compliance Report Public Rights-of-Way (Curb Ramps)

| Main Street: E_SPRING_ST | | Cross Street: EARLHAM_ST | | Location: | SE |
| ADA ID: RPAT210927111112 | Ramp Type: Type 4 - Parallel | Initial Pass/Fail: Fail | Overall Compliance: No | Severity Score: | 4 |

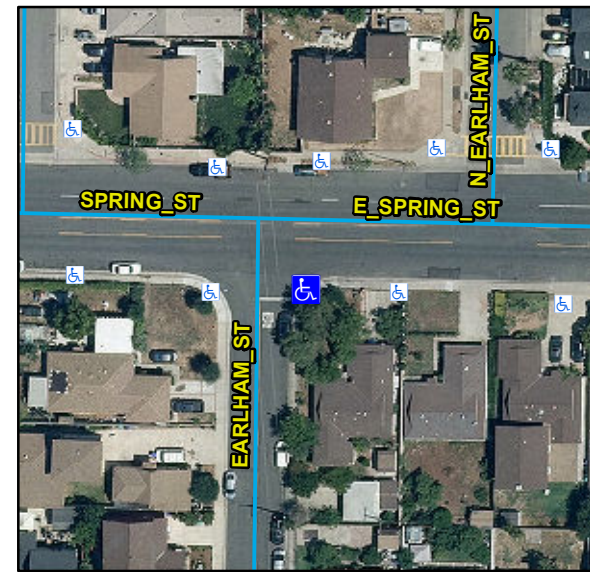
| Compliance | Description | Data | Compliance | Description | Data |
|---|---|---|---|---|---|
| Yes | Ramp Width LT (in) | 48 | No | Ramp Width RT (in) | 47 |

**Remove & Replace Curb Ramp With Two New Directional Ramps or Equivalent.**

**R304.5.1, STD 1115**

Total Cost: \$ 4000
