# Access Compliance Report Public Rights-of-Way (Curb Ramps)

Main Street: N\_WRIGHTWOOD\_ST Cross Street: SPRING\_ST Location: NE

ADA ID: RPAT210927111513 Ramp Type: Type 1 - Perpendicular Diagonal Initial Pass/Fail: Fail Overall Compliance: No Severity Score: 15

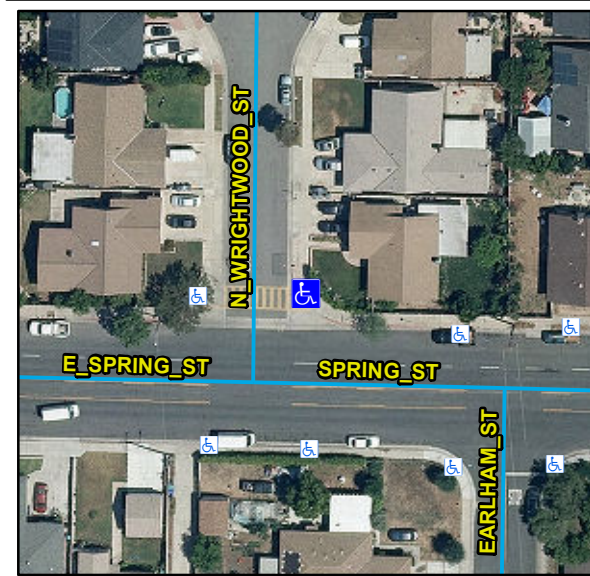
| Compliance | Description | Data | Compliance | Description | Data |
|---|---|---|---|---|---|
| No | Ramp Run Slope (%) | 10.6 | N/A | Flare Slope LT (%) | N/A |

Remove & Replace Curb Ramp With Two New Directional Ramps or Equivalent.

R304.2.2, STD 1115
