Access Compliance Report Public Rights-of-Way (Curb Ramps)

Main Street: E_SPRING_ST **Cross Street:** N_WRIGHTWOOD_ST **Location:** NW

ADA ID: RPAT210927111804 **Ramp Type:** Type 1 - Perpendicular Diagonal Initial Pass/Fail: Fail **Overall Compliance:** No **Severity Score:** 15

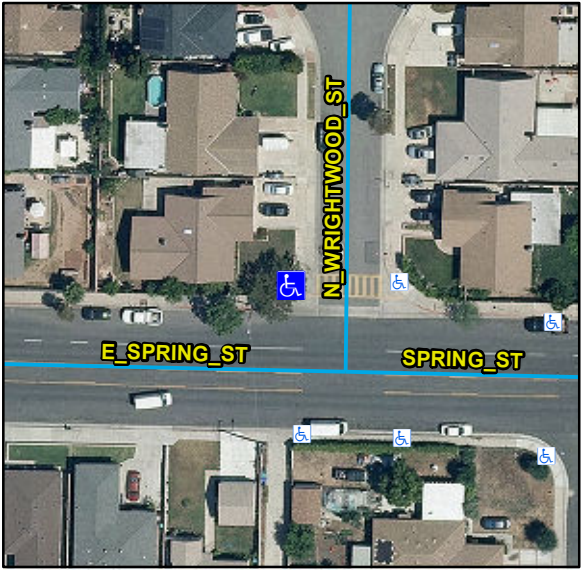
Compliance	Description	Data	Compliance	Description	Data
N/A	Ramp Length (in)	79	N/A	Flare Type LT	
Yes	Ramp Width (in)	50			N/A
No	Ramp Run Slope (%)	11.6	N/A	Flare Slope LT (%)	N/A
Yes	Ramp Cross Slope (%)	0.5	N/A	Flare Traversable LT	N/A
N/A	Landing Present	N/A	N/A	Flare Type RT	
N/A	Landing Length (in)	N/A			N/A
N/A	Landing Width (in)	N/A	N/A	Flare Slope RT (%)	N/A
N/A	Landing Run Slope (%)	N/A	N/A	Flare Traversable RT	N/A
N/A	Landing Cross Slope (%)	N/A	N/A	DWS Provided	N/A
N/A	Landing Movement Obstructed?	N/A	N/A	DWS Contrast	N/A
	Landing Movement Type	N/A	N/A	DWS Length (in)	N/A
N/A	Landing Shared	N/A	N/A	DWS Full Width	N/A
N/A	Clear Space	Yes	N/A	DWS Offset Left (in)	N/A
N/A	Clear Space To Crosswalk (in)	N/A	N/A	DWS Offset Right (in)	N/A
N/A	Marked Crosswalk 1	No	N/A	Marked Crosswalk 2	Yes
	Crossing 1 Direction	S		Crossing 2 Direction	E
	Marked Crosswalk 1 Width (in)	N/A		Marked Crosswalk 2 Width (in)	120

Possible Solutions:
Remove & Replace Curb Ramp With Two New Directional Ramps or Equivalent. Restripe Crosswalk.

OC Std/PROW:
 R304.2.2, STD 1115

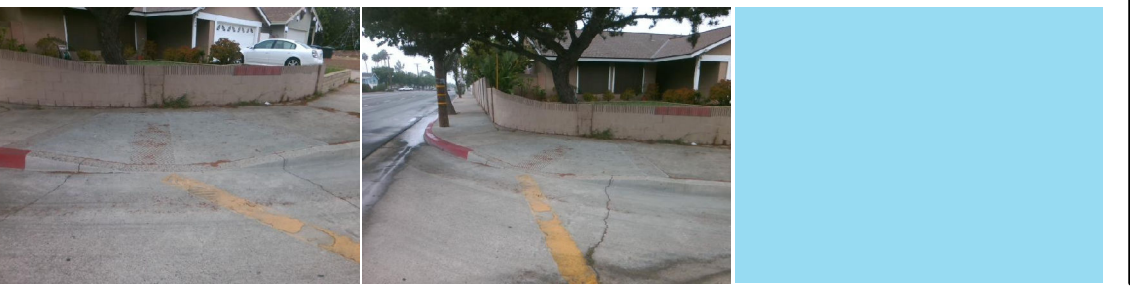
N/A	Ramp Inside Crosswalk 1	N/A	Yes	Ramp Inside Crosswalk 2	No
	Crossing 1 Slope (%)	5.4		Crossing 2 Slope (%)	0.8
	Crossing 1 Cross Slope (%)	0.3		Crossing 2 Cross Slope (%)	1.4
N/A	Gutter Ponding	N/A	N/A	Curb Slope	3.7
Yes	Gutter Lip Height (in)	0		Road Run Slope (%)	2.3
N/A	Gutter Run Slope (%)	N/A		Road Cross Slope (%)	2.3
N/A	Gutter Cross Slope (%)	N/A			
Yes	Overall Surface Condition: Acceptable		Yes	Perp Joint Present	Yes
	Cross Gutter Present?	Yes		Spandrel Present?	Yes
	Replace Cross Gutter?	No		Replace Spandrel?	No
