# Access Compliance Report Public Rights-of-Way (Curb Ramps)

Main Street: N\_GLENROSE\_DR Cross Street: E\_SPRING\_ST Location: NE

ADA ID: RPAT210927112213 Ramp Type: Type 1 - Perpendicular Diagonal Initial Pass/Fail: Fail Overall Compliance: No Severity Score: 15

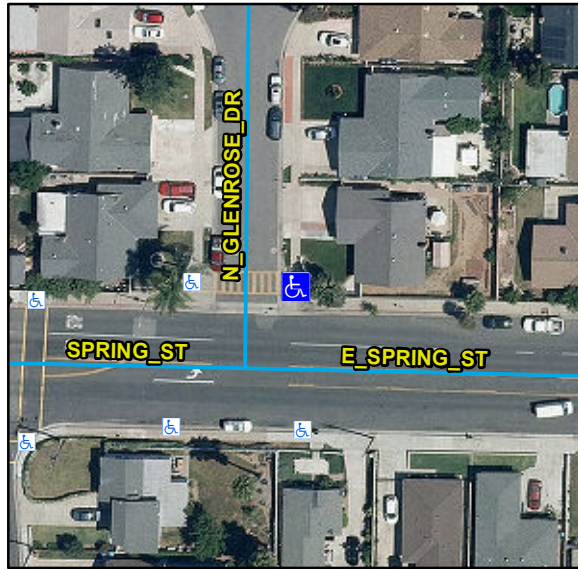
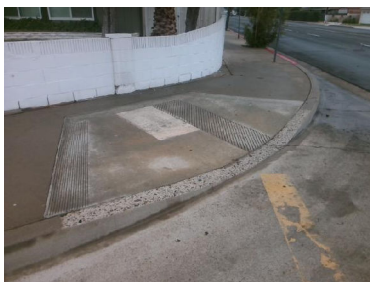
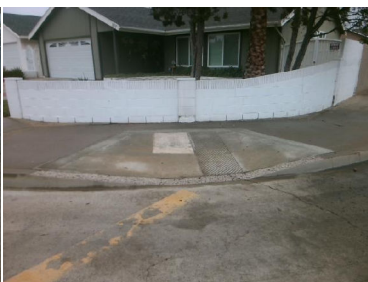
| Compliance | Description | Data | Compliance | Description | Data |
|---|---|---|---|---|---|
| No | Ramp Run Slope (%) | 10.1 | N/A | Flare Slope LT (%) | N/A |

**Remove & Replace Curb Ramp With Two New Directional Ramps or Equivalent. Restripe Crosswalk.**

**R304.2.2, STD 1115**
