# Access Compliance Report Public Rights-of-Way (Curb Ramps)

Main Street: SPRING\_ST Cross Street: N\_GLENROSE\_DR Location: NW

ADA ID: RPAT210927112458 Ramp Type: Type 1 - Perpendicular Diagonal Initial Pass/Fail: Fail Overall Compliance: No Severity Score: 15

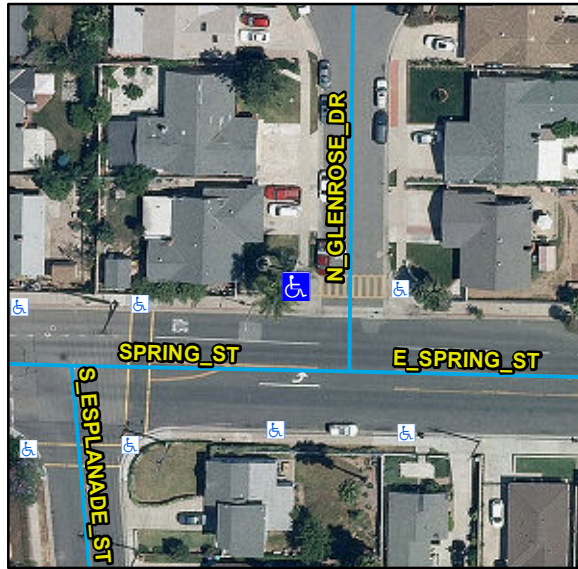
| Compliance | Description | Data | Compliance | Description | Data |
|---|---|---|---|---|---|
| No | Ramp Run Slope (%) | 10.8 | N/A | Flare Slope LT (%) | N/A |

Remove & Replace Curb Ramp With Two New Directional Ramps or Equivalent. Restripe Crosswalk.

R304.2.2, STD 1115
