# Access Compliance Report Public Rights-of-Way (Curb Ramps)

| Main Street: SPRING_ST | | Cross Street: S_ESPLANADE_ST | | Location: | NE |
| ADA ID: RPAT210927112835 | Ramp Type:Type 1 - Perpendicular | Initial Pass/Fail: Fail | Overall Compliance: No | Severity Score: | 15 |

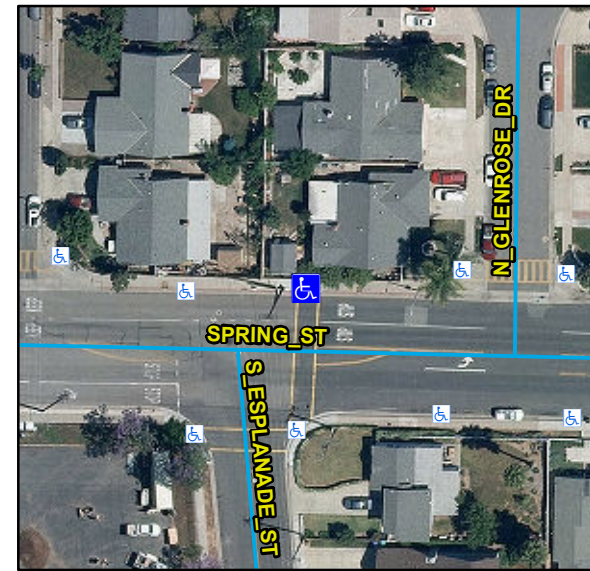
| Compliance | Description | Data | Compliance | Description | Data |
|---|---|---|---|---|---|
| No | Ramp Run Slope (%) | 10.5 | N/A | Flare Slope LT (%) | N/A |

Remove & Replace Entire Ramp.

R304.2.2, STD 1115

Total Cost: \$ 3080
