# Access Compliance Report Public Rights-of-Way (Curb Ramps)

| Main Street: N_ESPLANADE_ST | | Cross Street: SPRING_ST | | Location: | NE |
| ADA ID: RPAT210927113106 | Ramp Type:Type 1 - Perpendicular | Initial Pass/Fail: Fail | Overall Compliance: No | Severity Score: | 30 |

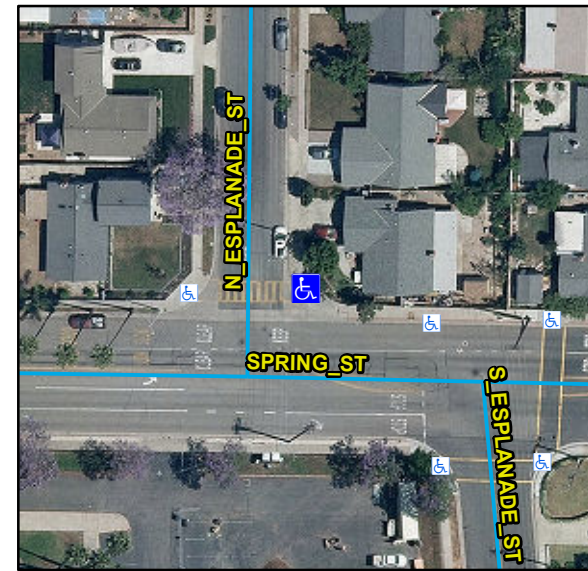
| Compliance | Description | Data | Compliance | Description | Data |
|---|---|---|---|---|---|
| No | Ramp Run Slope (%) | 14.6 | N/A | Flare Slope LT (%) | N/A |

Possible Solutions:

Remove & Replace Entire Ramp.

R304.2.2, STD 1115
