# Access Compliance Report Public Rights-of-Way (Curb Ramps)

| Main Street: N_ESPLANADE_ST | | Cross Street: SPRING_ST | | Location: | NW |
| ADA ID: RPAT210927113410 | Ramp Type:Type 1 - Perpendicular | Initial Pass/Fail: Fail | Overall Compliance: No | Severity Score: | 32 |

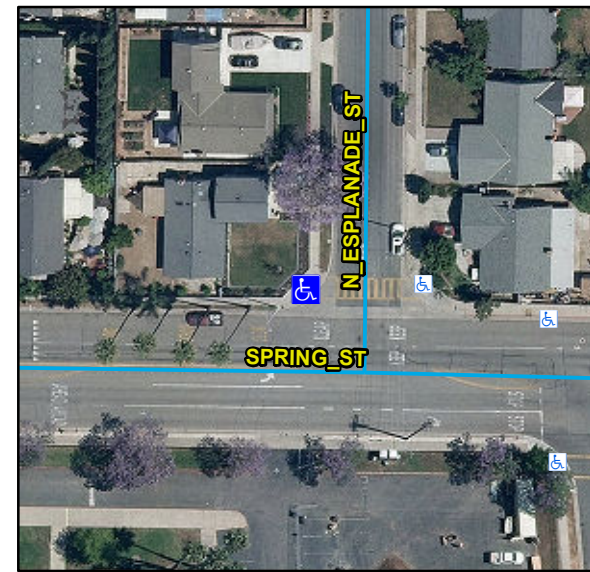
| Compliance | Description | Data | Compliance | Description | Data |
|---|---|---|---|---|---|
| No | Ramp Run Slope (%) | 13.7 | N/A | Flare Slope LT (%) | N/A |
| No | Ramp Cross Slope (%) | 4.2 | N/A | Flare Traversable LT | N/A |

**Remove & Replace Entire Ramp. Restripe Crosswalk.**

**R304.2.2, R304.5.3, STD 1115**

Total Cost: \$ 7080

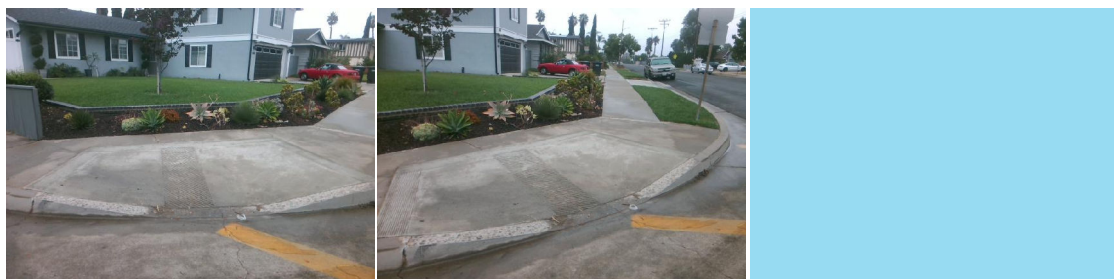
| Compliance | Description | Data | Compliance | Description | Data |
|---|---|---|---|---|---|
| N/A | Ramp Length (in) | 75 | N/A | Flare Type LT | |
| Yes | Ramp Width (in) | 51 | | | N/A |
