# Access Compliance Report Public Rights-of-Way (Curb Ramps)

Main Street: E\_VINE\_ST Cross Street: S\_ESPLANADE\_ST Location: SE

ADA ID: RPAT210927115429 Ramp Type: Type 4 - Parallel Initial Pass/Fail: Fail Overall Compliance: No Severity Score: 4

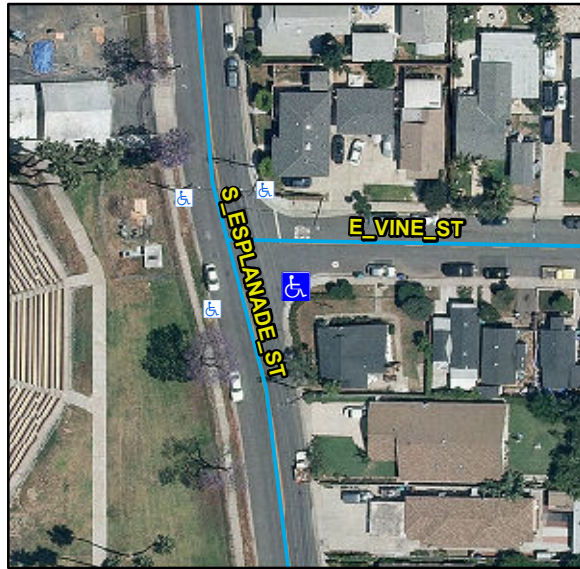
| Compliance | Description | Data | Compliance | Description | Data |
|---|---|---|---|---|---|
| Yes | Ramp Width LT (in) | 48 | No | Ramp Width RT (in) | 47 |

Remove & Replace Curb Ramp With Two New Directional Ramps or Equivalent.

R304.5.1, STD 1115
